**REAL LIFE CASE STUDIES ON  
DIAGNOSIS AND SOLUTIONS FOR  
POWER QUALITY RELATED PROBLEMS**

**Presented by :  
Rajen Mehta / Kartik Parekh**

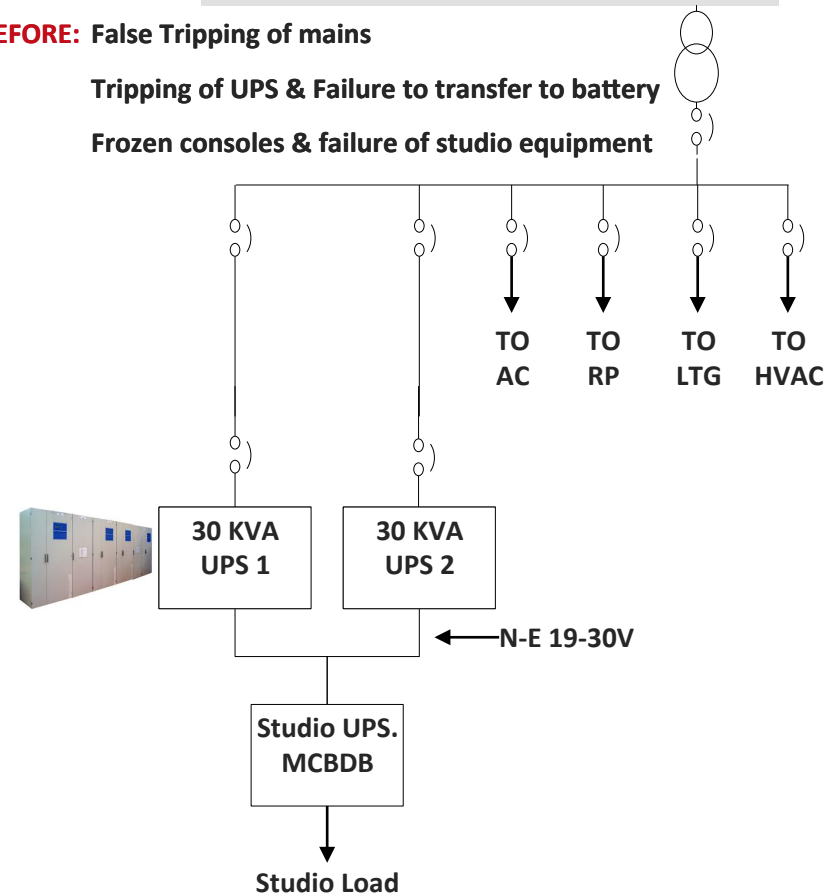
- Lot of noise signals observed in the transmission of the audio signals. Some direct symptoms were freezing of the consoles and UPS Tripping inadvertently.
- Study revealed that the Raw Power Neutral conductor potential was varying from 0.5Volt to as high as 30V between Neutral and Earth Conductor due to leakage potentials from neighbouring loads inspite multiple neutral grounding and equipment grounding.
- This floating Neutral-Earth Potential conditions was causing 2 issues :
  - bad power quality input to UPS
  - freezing of on-air studio equipment resulting in huge revenue loss
- Further the freezing was attributed to the earthing of UPS, servers, desktops and on-air studio equipments connected to a common earth junction.

**BEFORE: False Tripping of mains**

**Tripping of UPS & Failure to transfer to battery**

**Frozen consoles & failure of studio equipment**

- Install zero sequence filter transformer with ultra isolation which would serve multiple purposes
  - of providing dedicated neutral
  - of effectively providing stable neutral under unbalanced voltage condition at the input side.
  - of reducing the N-E voltage and isolating the input Power quality problems.
- At the same time changes in earthing of neutral, body and equipment were also recommended
- Lastly Class 2 surge suppressors were also recommended to clamp the P-N peak voltages more than 500V (due to high neutral displacement conditions of upto 30V)

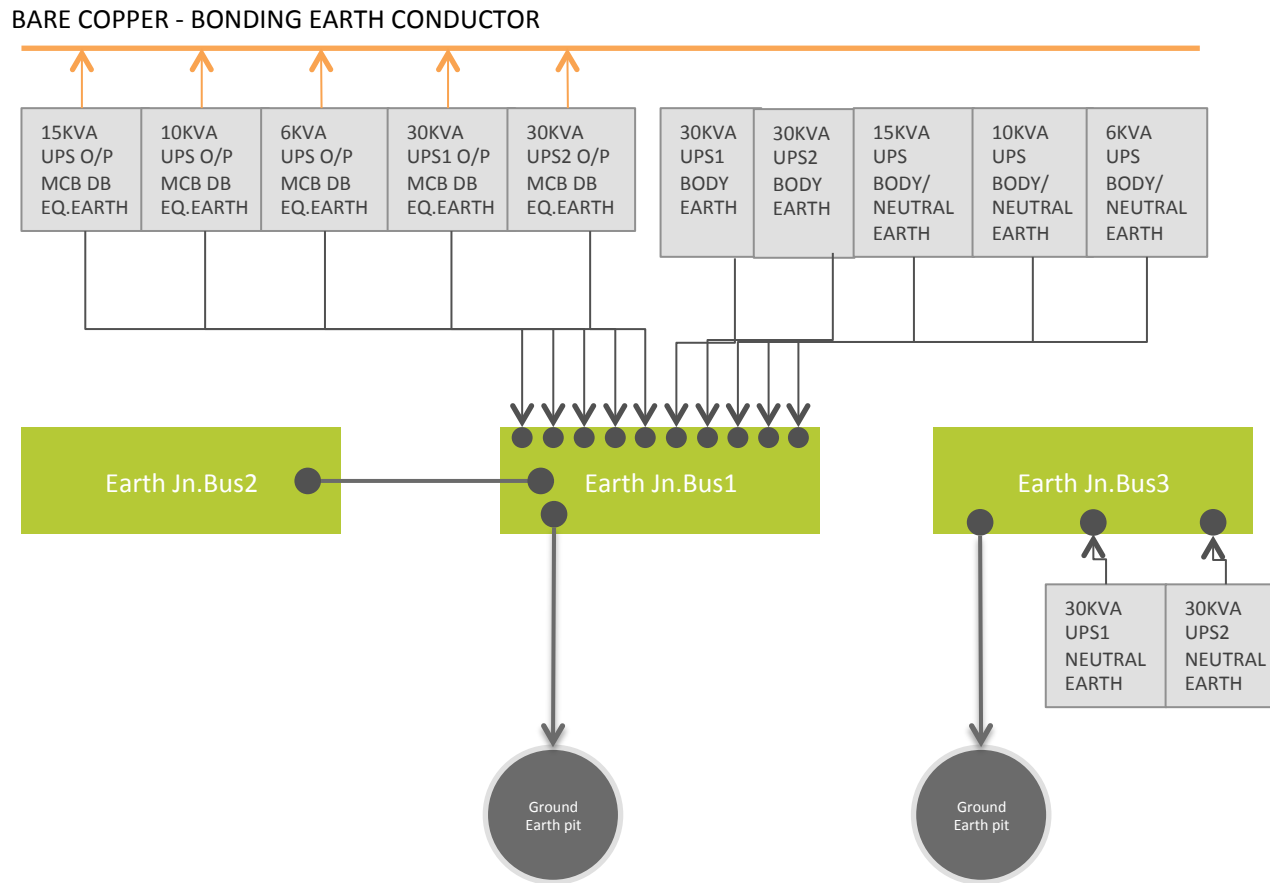
### UPS room earthing – Before

- **30KVA UPS 1 – Neutral earth: 100mA – 600mA**
- **30KVA UPS 1 – Neutral earth: 100mA – 600mA**
- **All UPS MCBDB Equipment earth: 0 to <200mA**
- **Zero Sequence Xfmr– output Neutral earth: 100mA – 300mA**
- **Zero Sequence Xfmr – output Body earth: <300mA**
- **Neutral to earth voltage: 18-30V**
- **Phase voltages: 240 V to 245V**

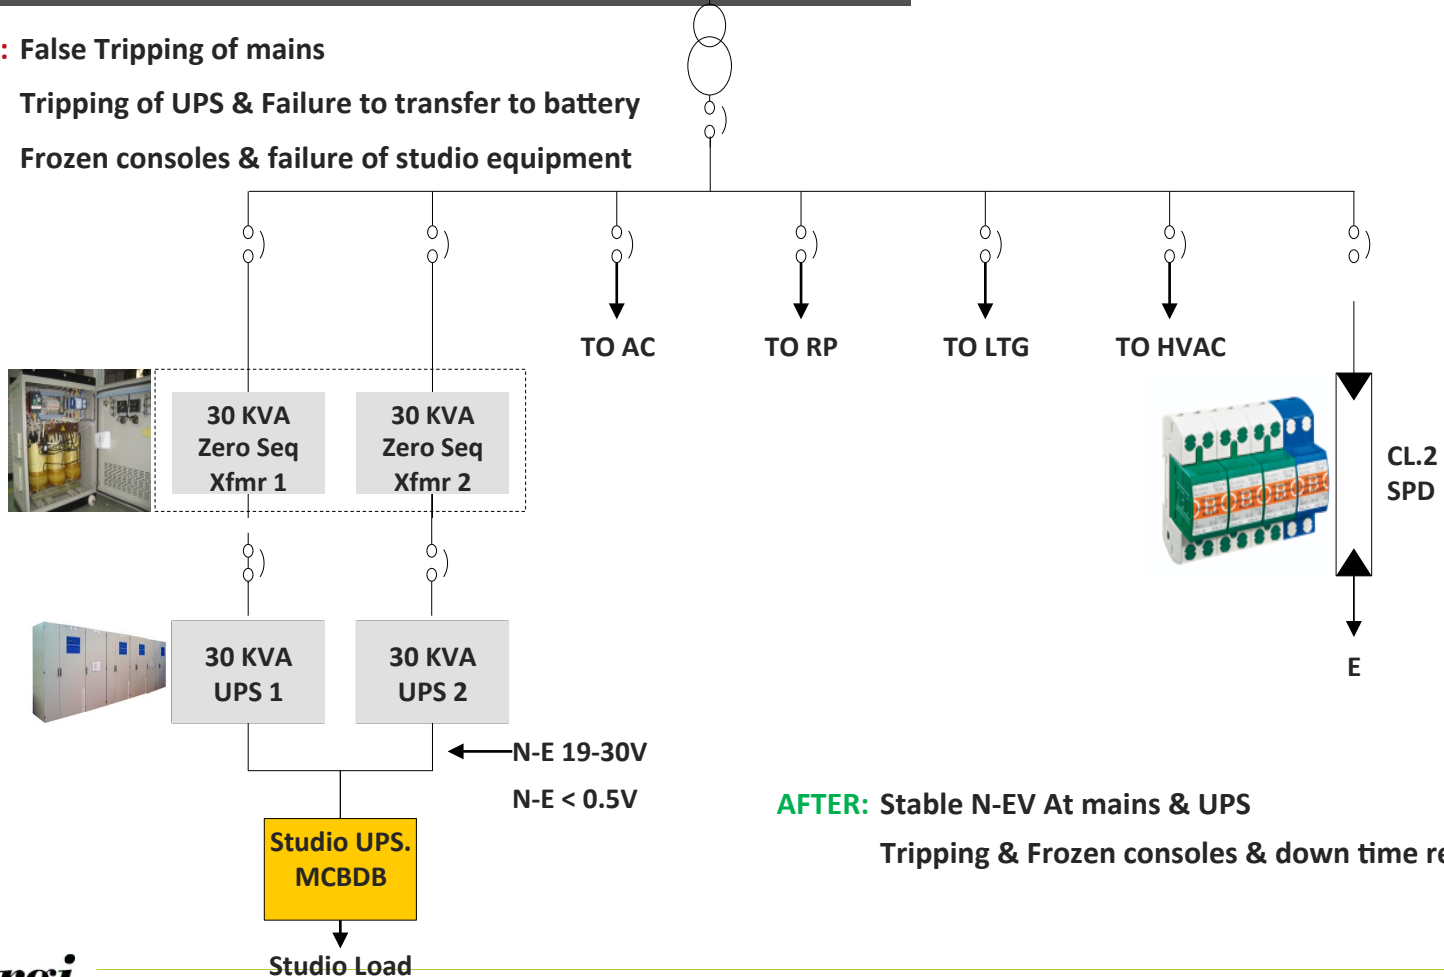
**BEFORE:** False Tripping of mains

Tripping of UPS & Failure to transfer to battery

Frozen consoles & failure of studio equipment

**AFTER:** Stable N-EV At mains & UPS

Tripping & Frozen consoles & down time reduced

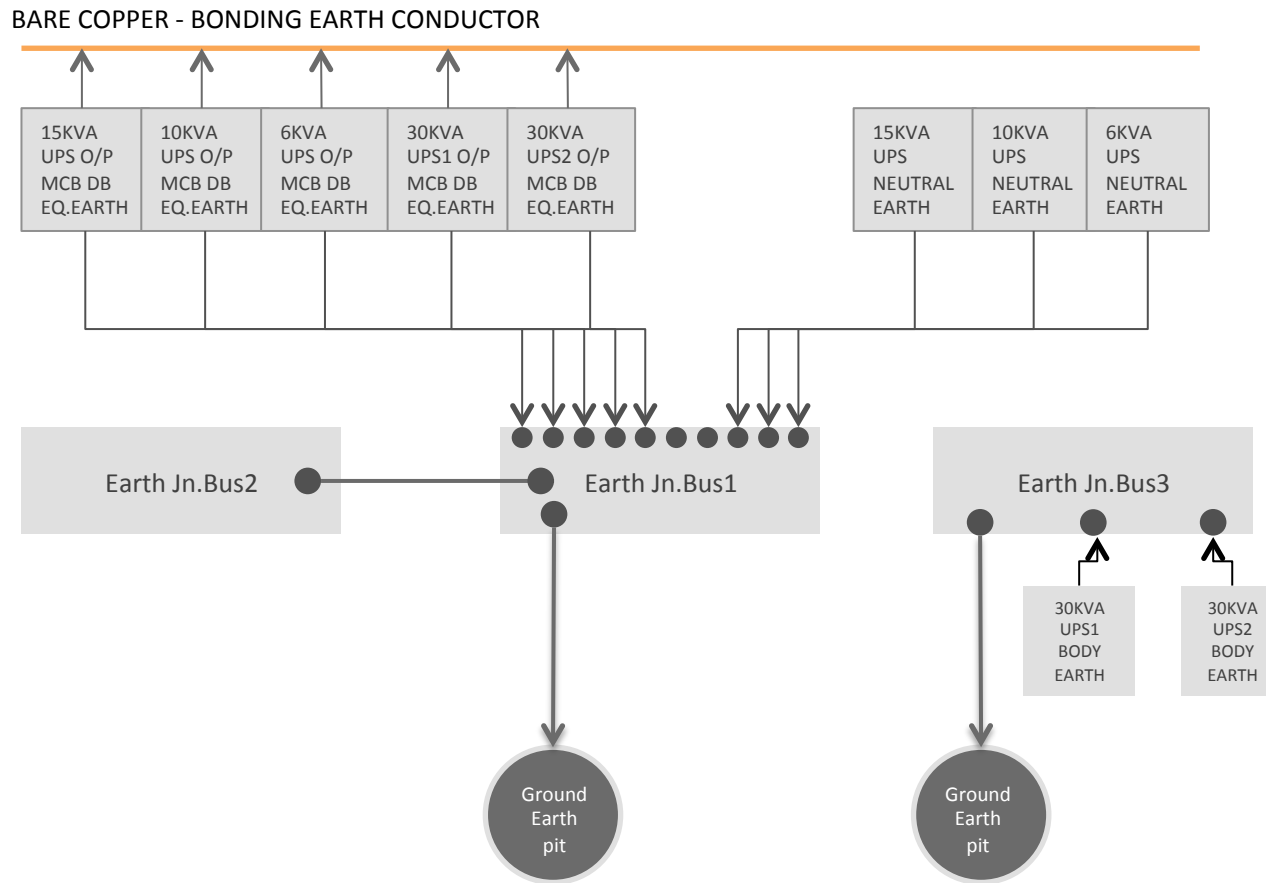
### UPS room earthing – After

- **30KVA UPS 1 – Neutral earth: 50mA – 200mA**
- **30KVA UPS 1 – Neutral earth: 50mA – 200mA**
- **All UPS MCBDB Equipment earth: 0 to <100mA**
- **Zero Sequence Xfmr – output Neutral earth: 10mA – 50mA**
- **Zero Sequence Xfmr – output Body earth: <300mA**
- **Neutral to earth voltage: 0.5Volt**
- **Phase voltage: 240V to 245V**

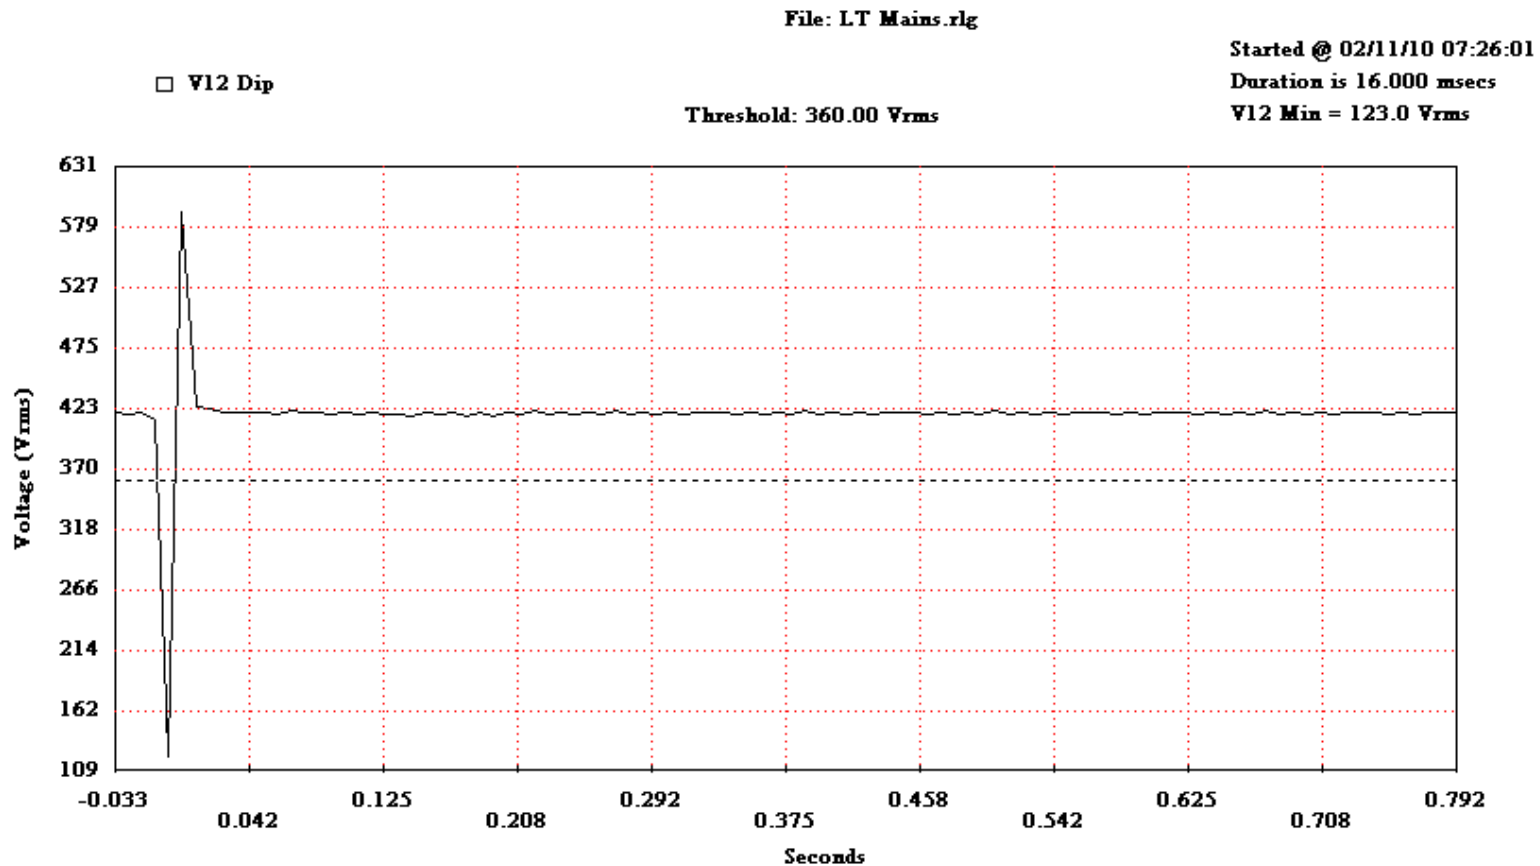
Over Voltages (+10% to +25%) & Voltage swells  
Voltage dropouts (-10% to - 100%) & Voltage dips

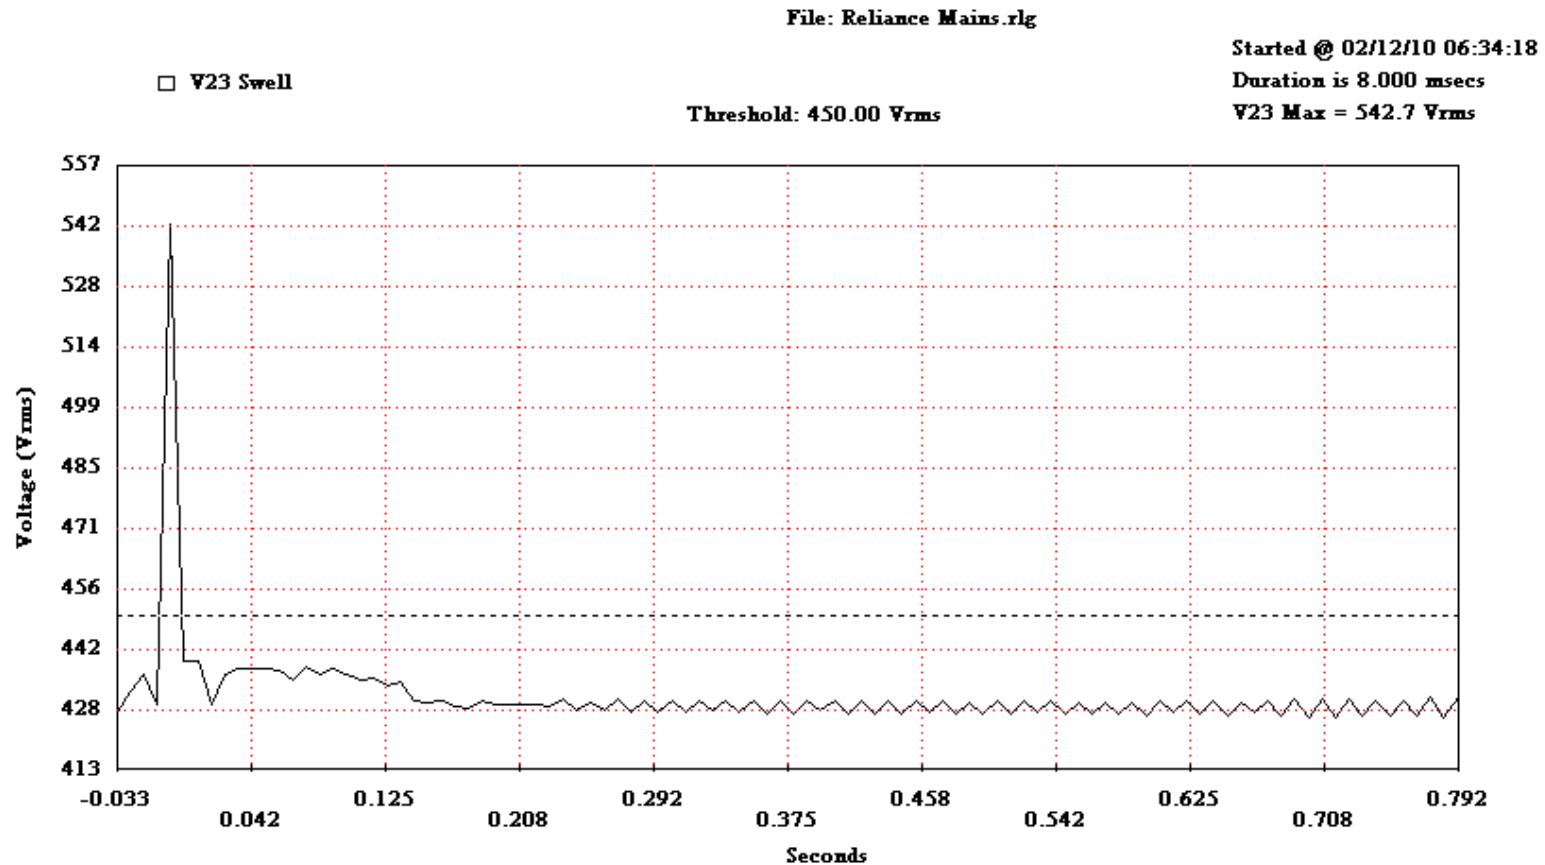
Over Voltages (+10% to +25%) & Voltage swells  
Voltage dropouts (-10% to - 100%) & Voltage dips

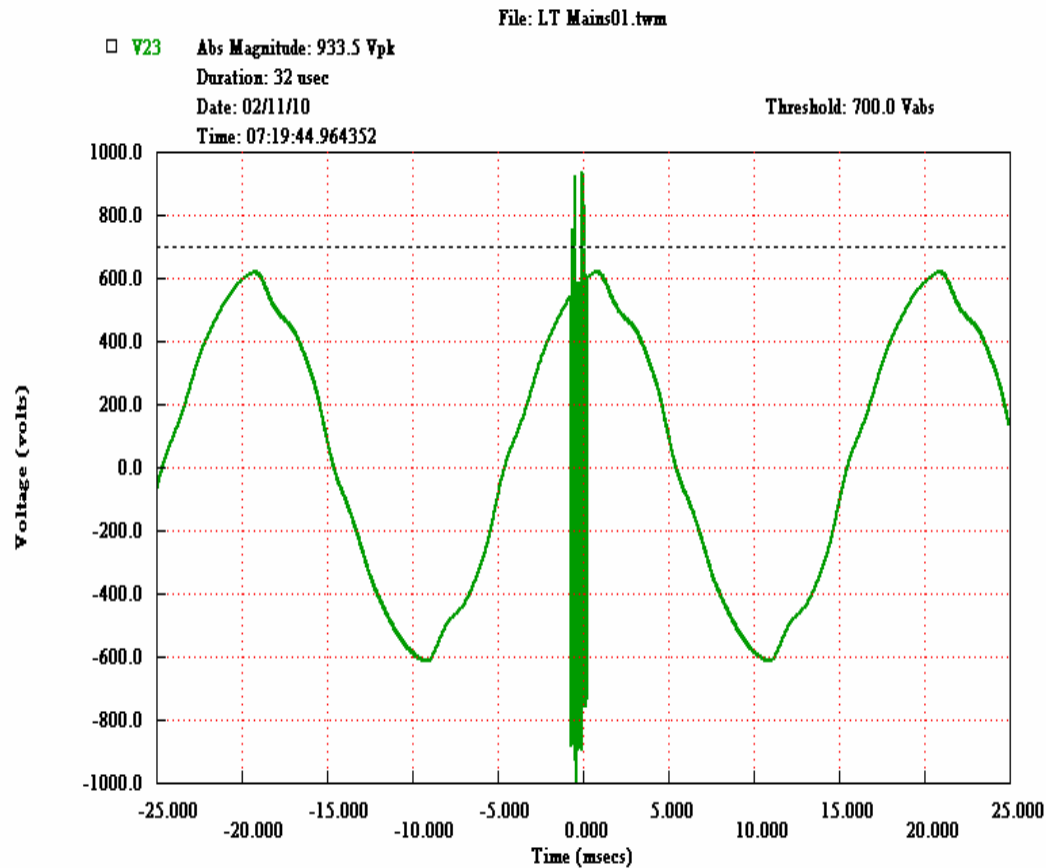
Fast Voltage Changes (steps with high dV/dt)  
 Spikes & Notches (pulses with high dV/dt)

Spikes & Notches				
RELIANCE MAINS	Time	Ph	Duration	Magnitude
11/02/2010	07:19:44	V23	32 usec	933.5
12/02/2010	06:34:18	V31	873 usec	833.1
12/02/2010	11:46:24	V23	8 usec	-976
12/02/2010	12:16:36	V31	89 usec	971
12/02/2010	16:05:20	V23	8 usec	-747.1
13/02/2010	08:22:11	V31	609 usec	-710

- **External Disturbance** - The disturbances were external particularly because a detailed analysis of client load patterns did not reveal any major fluctuating load patterns or any changes recently made.
- **Ineffective voltage clamping** – Installed TVSS were ineffective in clamping the fast voltage changes that were recorded. It was able to record the transient, but unable to filter the same.

- **HT Capacitor switching problem** – A more detailed second study revealed the source of disturbance to be the HT Capacitor switching. It was also observed that the occasional high voltage transients did not affect the equipment.
- **Unstable network** - Further detailed study of the earthing system, earth pit impedances and ground resistivity revealed high neutral-earth resistance, hence a weak source neutral. So in effect the network was unable to sustain the high dv/dt HT transients since the neutral was unstable on LT side and that got coupled with a network having leading PF condition making it capacitive in nature which was amplifying the high dv/dt from HT side.

- Company to ensure switching of the capacitors was done in stages to prevent transients of high magnitude
- To evaluate possibility to route the client supply through a more robust feeder

- Mitigation equipment for arresting such transients were suggested at the facility mains and near the submains and equipment sub DBs.
- Decoupling inductance, k-30 rated were recommended
- Mitigating coupling channel effect by:
  - tuning PF compensation equipment
  - Installing a low impedance earth derivative to provide the stable neutral under transient state of the network at the transformer secondary so that damaging effect of transients was avoided.

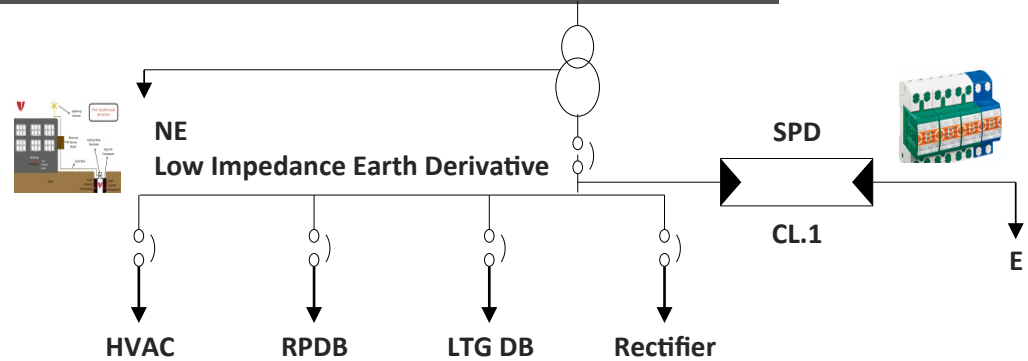
**BEFORE:** Damaging transients from grid  
 Failure of rectifier power modules  
 Neutral displacement and Stray Leakage very high

**AFTER:** Identified cause of Transients due to EB  
 Capacitor switching  
 Arrested failures of rectifiers

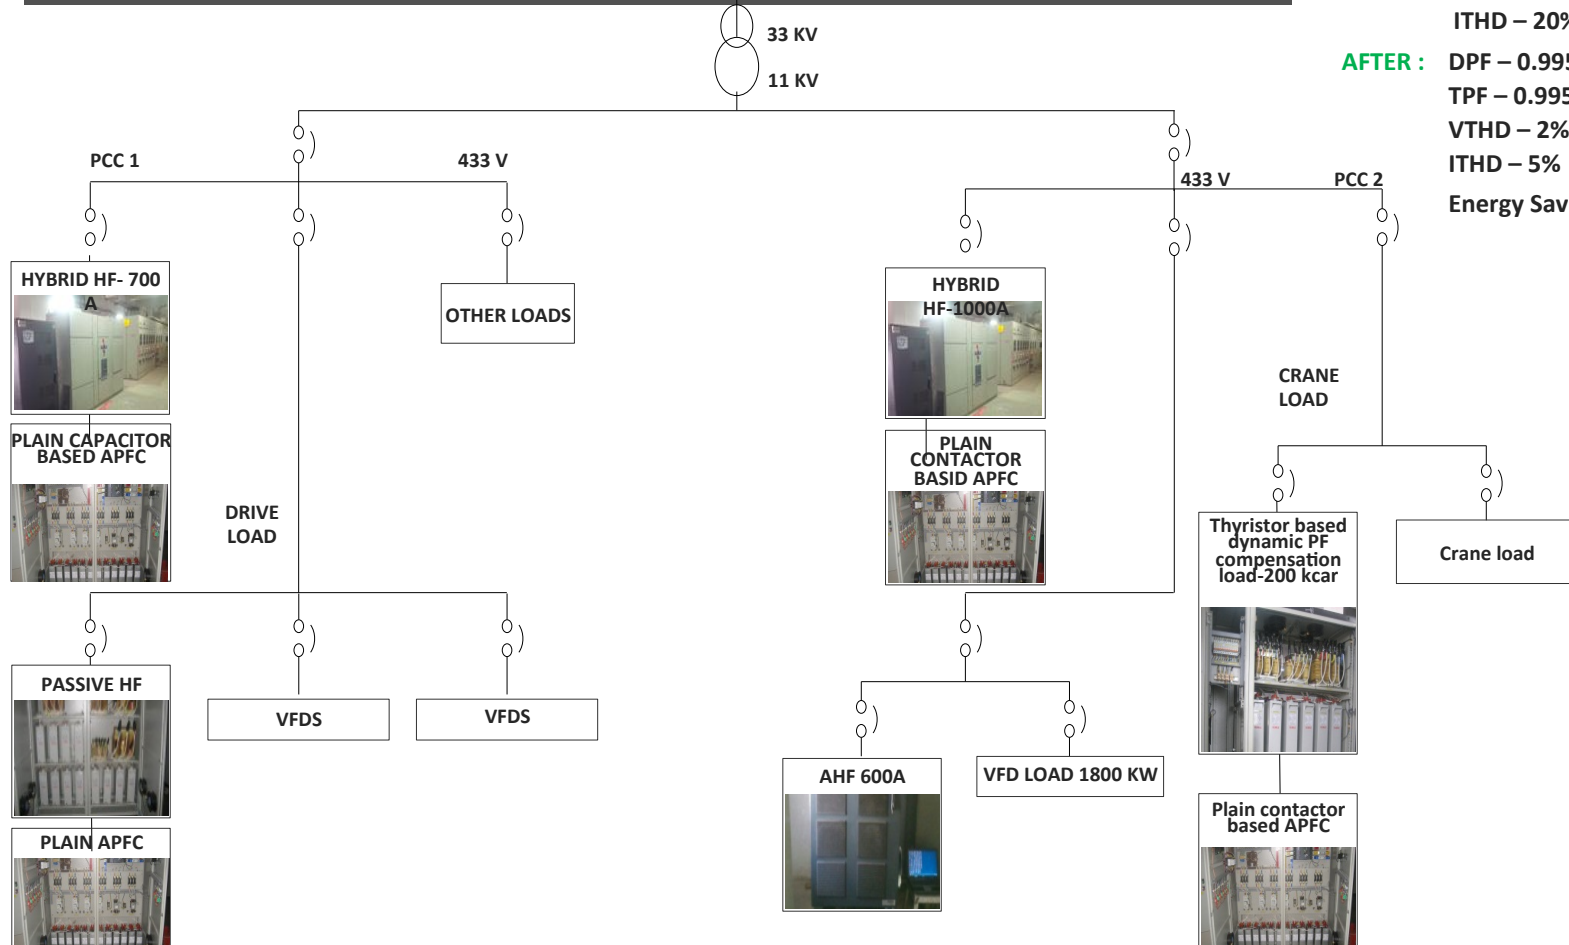
- Motor locking or process stoppages and humming noise from capacitor banks
- The 7% detuned PF compensation equipment remained ON when plant ran frequently on DG set
- 7-9% voltage distortion due to non-linear load with 6 pulse rectifiers, during the times of DG running
- This caused extreme stress on the detuned banks and causing in a short period of time premature derating of the capacitor banks and further tuning them towards the predominant 5th harmonic resulting in humming of the reactors.
- With respect to the process stoppages, flat topping of the voltage waveforms (due to high voltage distortion) lowered the output DC link voltage and thus confusing the drive and causing it to shunt between precharge mode and normal and in the process causing stoppage of output to motor.

**BEFORE :** DPF – 0.99  
 TPF – 0.95  
 VTHD – 6-7%  
 ITHD – 20%

**AFTER :** DPF – 0.995  
 TPF – 0.995  
 VTHD – 2%  
 ITHD – 5%

Energy Savings of about 5-6%

- Recommendations involved taking into consideration the PQ problems and the coupling channel
  - Upgrade the Detuned PF compensation equipment to a Hybrid Harmonic Filter (Active + Passive) due to the variable source impedance as well as very high distortions near load end due to majority of non-linear load
  - Distribute load such that a single generator would not be loaded with more than 25-30% of non-linear load
  - Consult Drive manufacturer to modify control such that generator feedback could be incorporated
