# Electric Vehicle charger case study

# Power Quality study for EV charger post

- Manufacturer of EV has experienced several internal battery charger failures in new EV's
- 2 sites, 1 in Arizona USA, 1 in Seoul, Korea

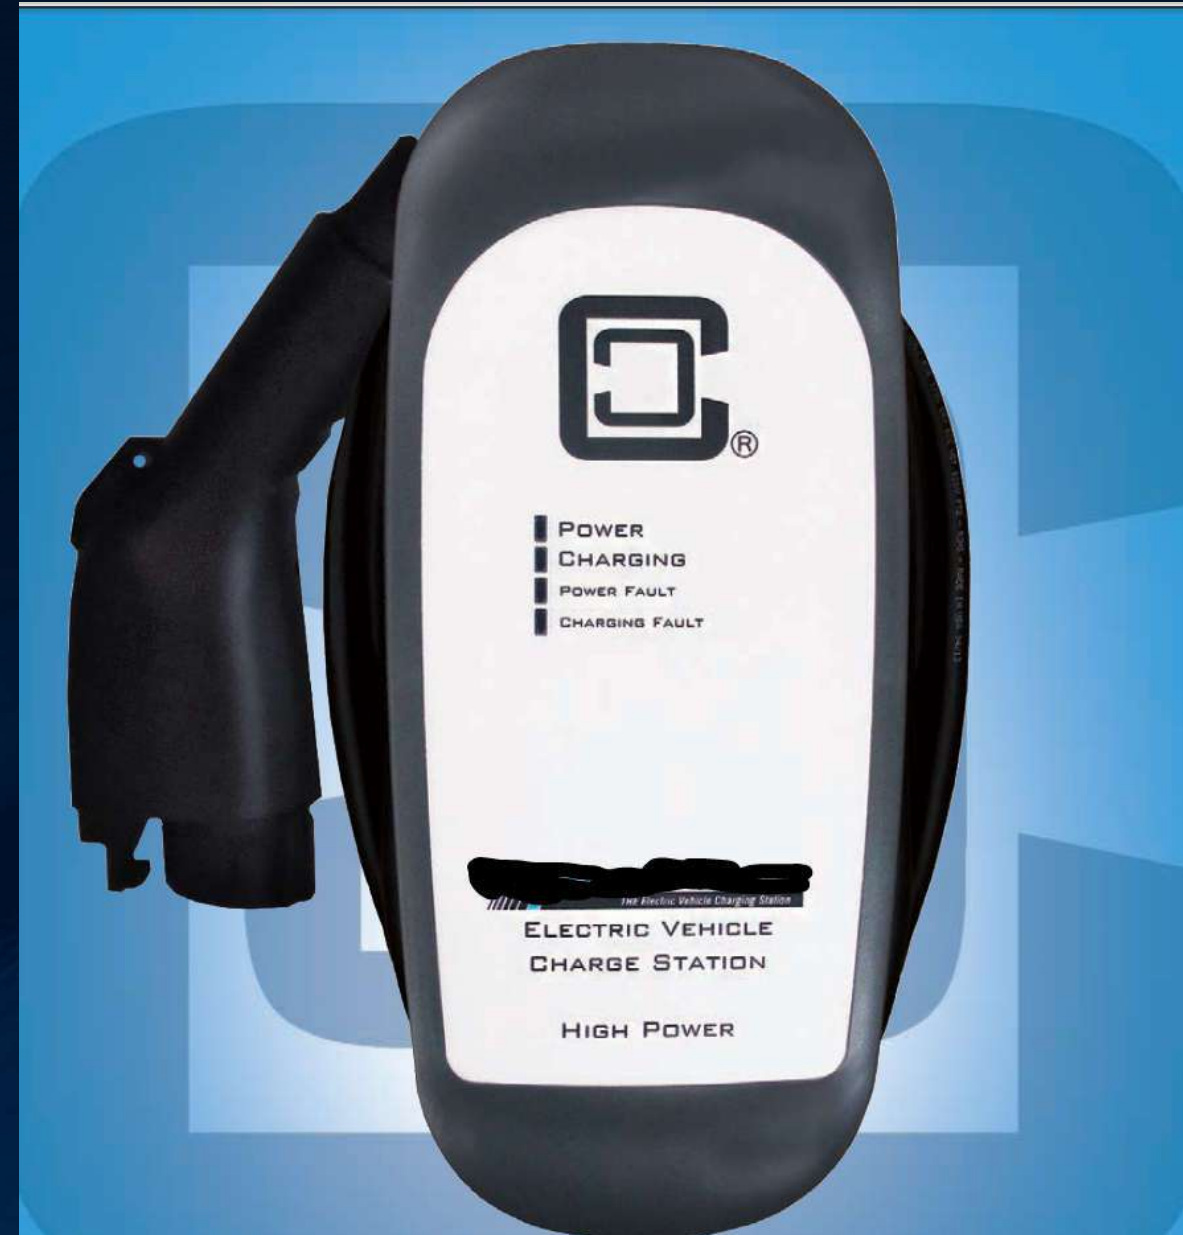
**FAST CHARGING** - 7.7kW of power to charge your vehicle quickly

- **QUALITY** - Technology that works for the life of your current plug-in vehicle and then some
- **CONVENIENT** - 25 feet of charging cable for installation and operation flexibility
- **DURABLE** - Rugged, fully sealed NEMA 4 enclosure for installation anywhere

The front panel on the HCS has four indicator lights, as shown in Figure 1:

**POWER** (yellow), indicates that power is available to the HCS.

**CHARGING** (green), indicates that the vehicle is requesting a charge and AC power is currently applied to the vehicle.

**POWER FAULT** (red), indicates that the HCS is not wired correctly. The problem can be due to improper grounding or a missing Earth Ground. The wiring should be examined by a qualified electrician.

**CHARGING FAULT** (red), indicates that the HCS is unable to communicate with the vehicle correctly, or a safety fault condition has been detected by the unit.

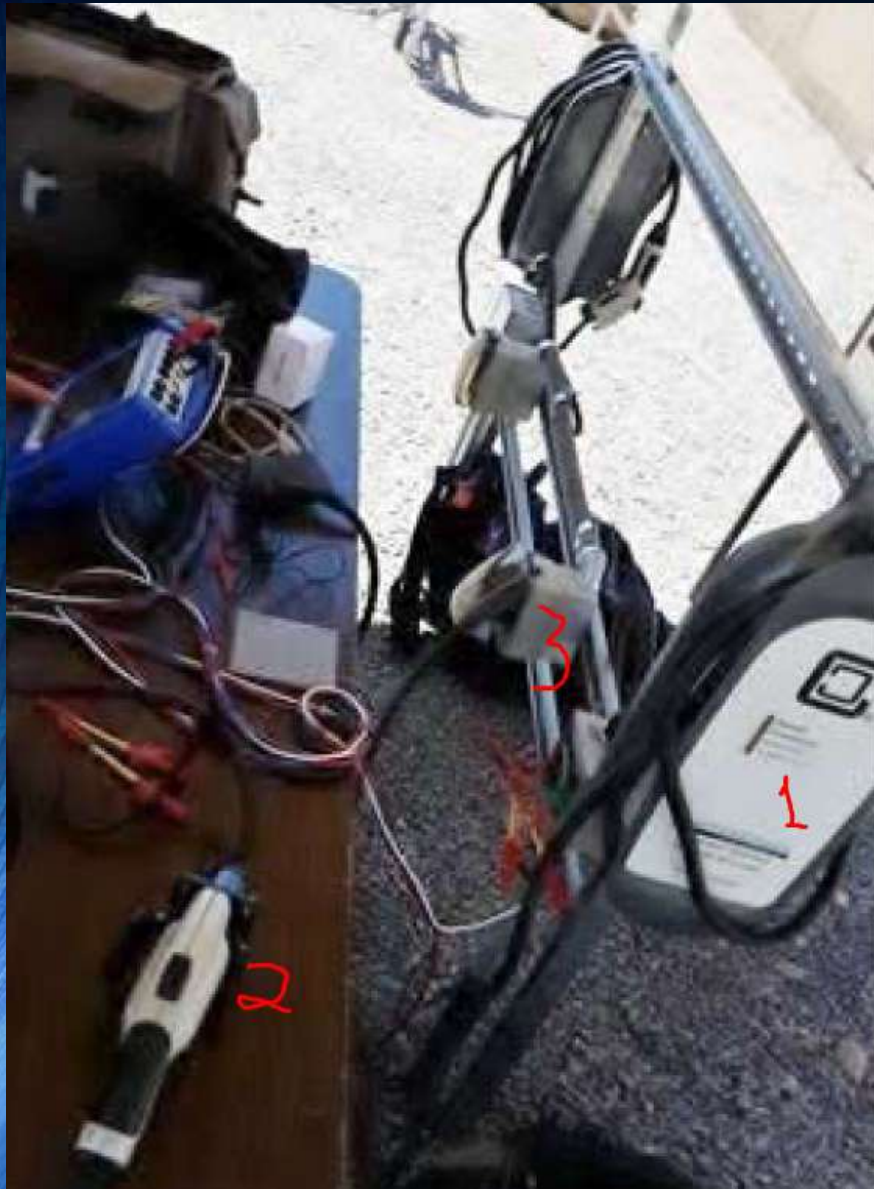
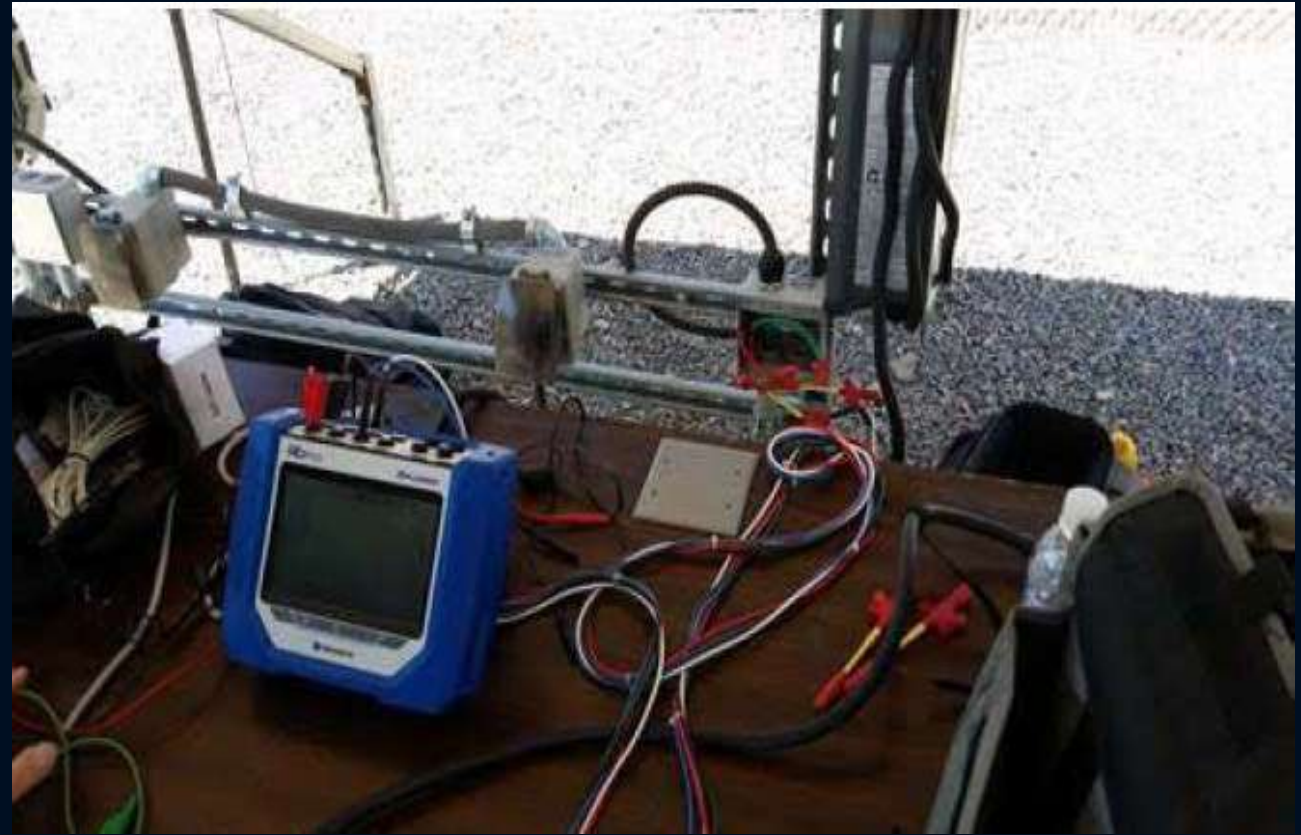
Dranetz HDPO monitor connected to incoming voltage of charger post

- Weather conditions, 105 to 120 degrees F.
  - HCS Maximum Operating Temperature:  $-30^{\circ}\text{C}$  to  $+50^{\circ}\text{C}$  ( $-22^{\circ}\text{F}$  to  $+122^{\circ}\text{F}$ )
- Two cars were used for testing
- Dranetz HDPO Explorer with 3 range Flexi CTs for recording voltage and current
- Channel A was connected to the 208V input to NCS-40 charger control panel.
- Channel C was connected to a test cable from the charger to the car.
- Installed 1 each Dranetz PowerVisa PQ monitor at Charging post B

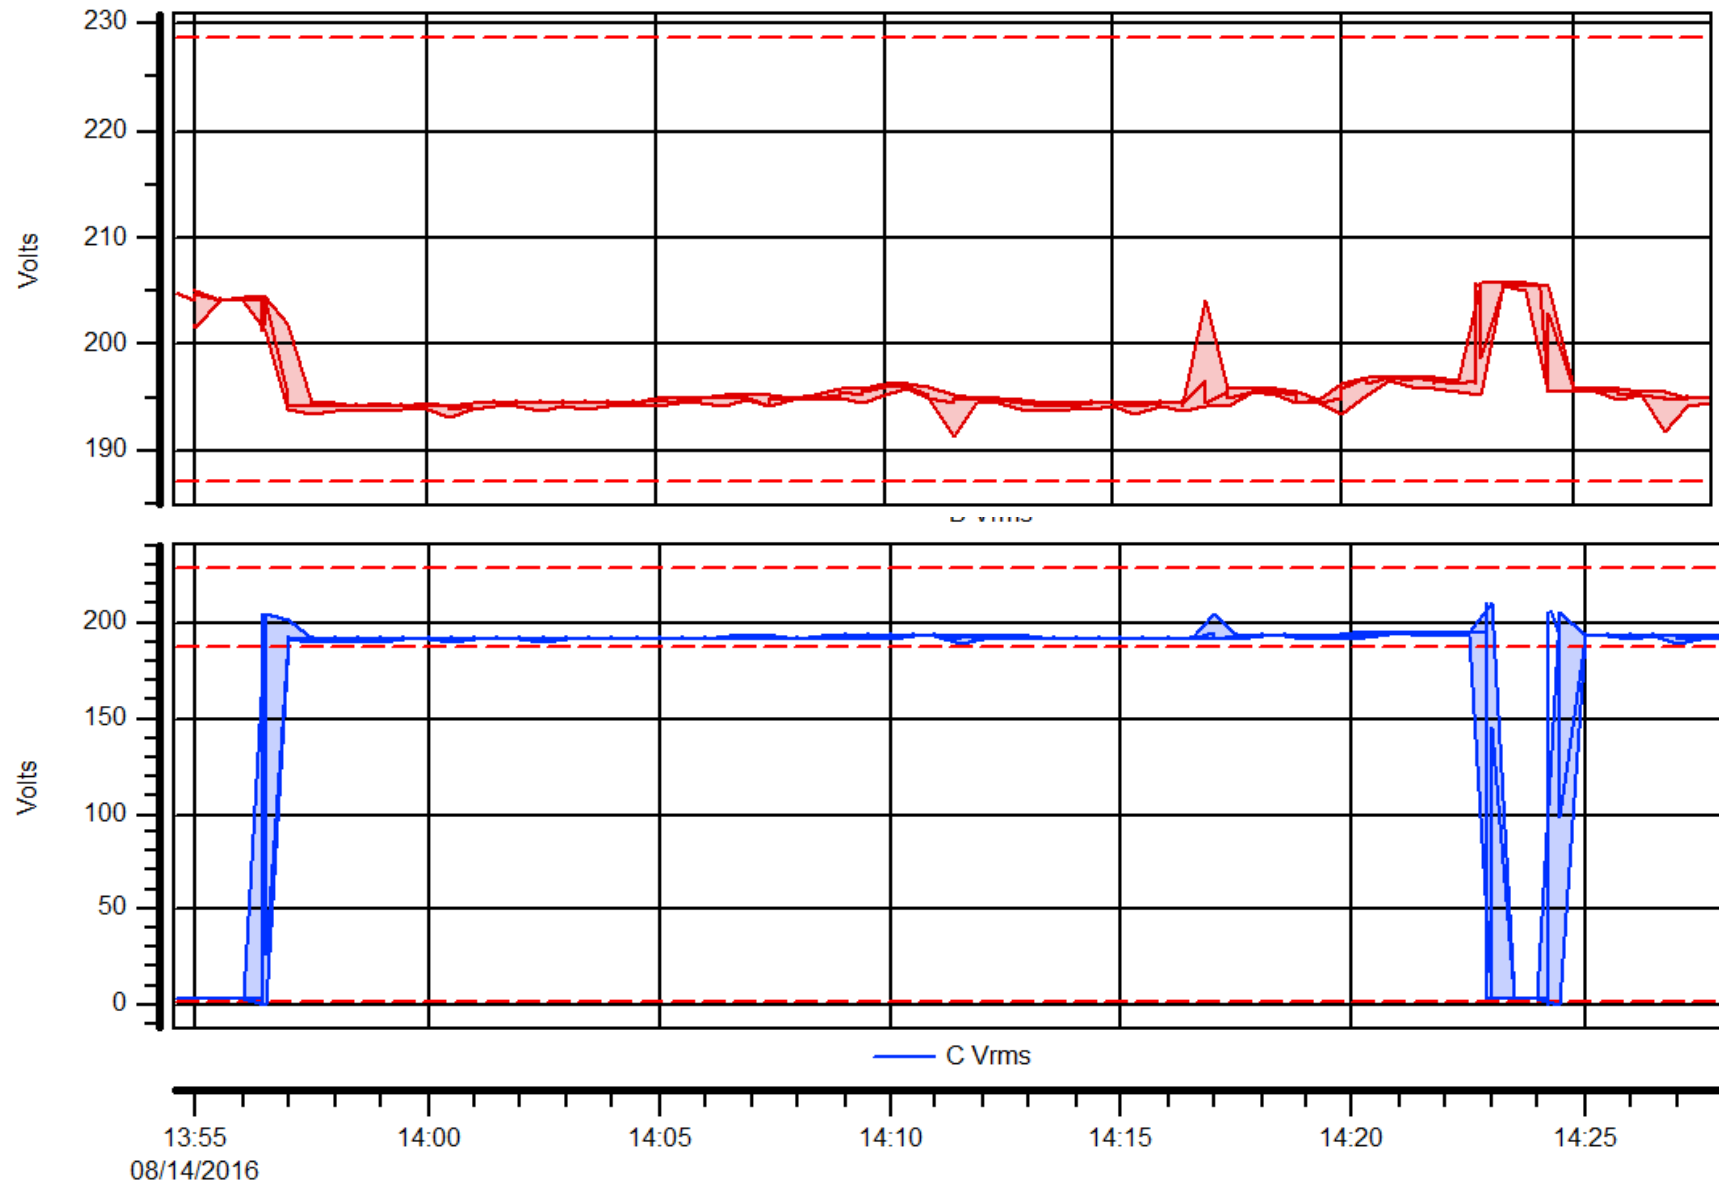
# Input and output voltage of NCS when attached to car and while charging

Site: OUTPUT INPUT

Measured from 08/14/2016 13:54:33.0 to 08/14/2016 14:28:00.0

- Output voltage delayed until car charger signal
- Output current delayed and slowly ramps up. More details needed. But apparent “soft start”
- Large very fast voltage transient recorded during connection time
- Voltage dropped when charging started.

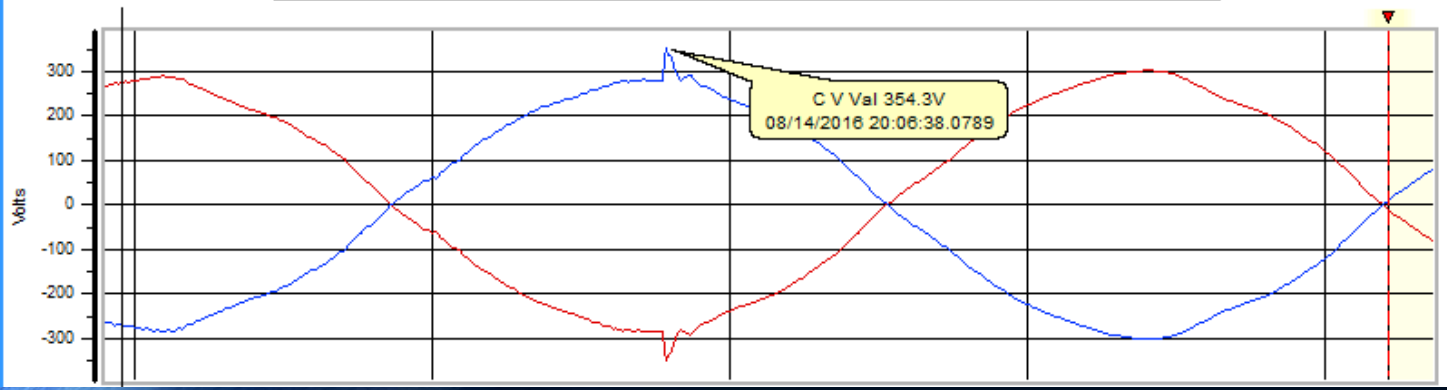
- When charger shuts off, voltage transient.

Peak of RMS voltage occurs after the charger current is off

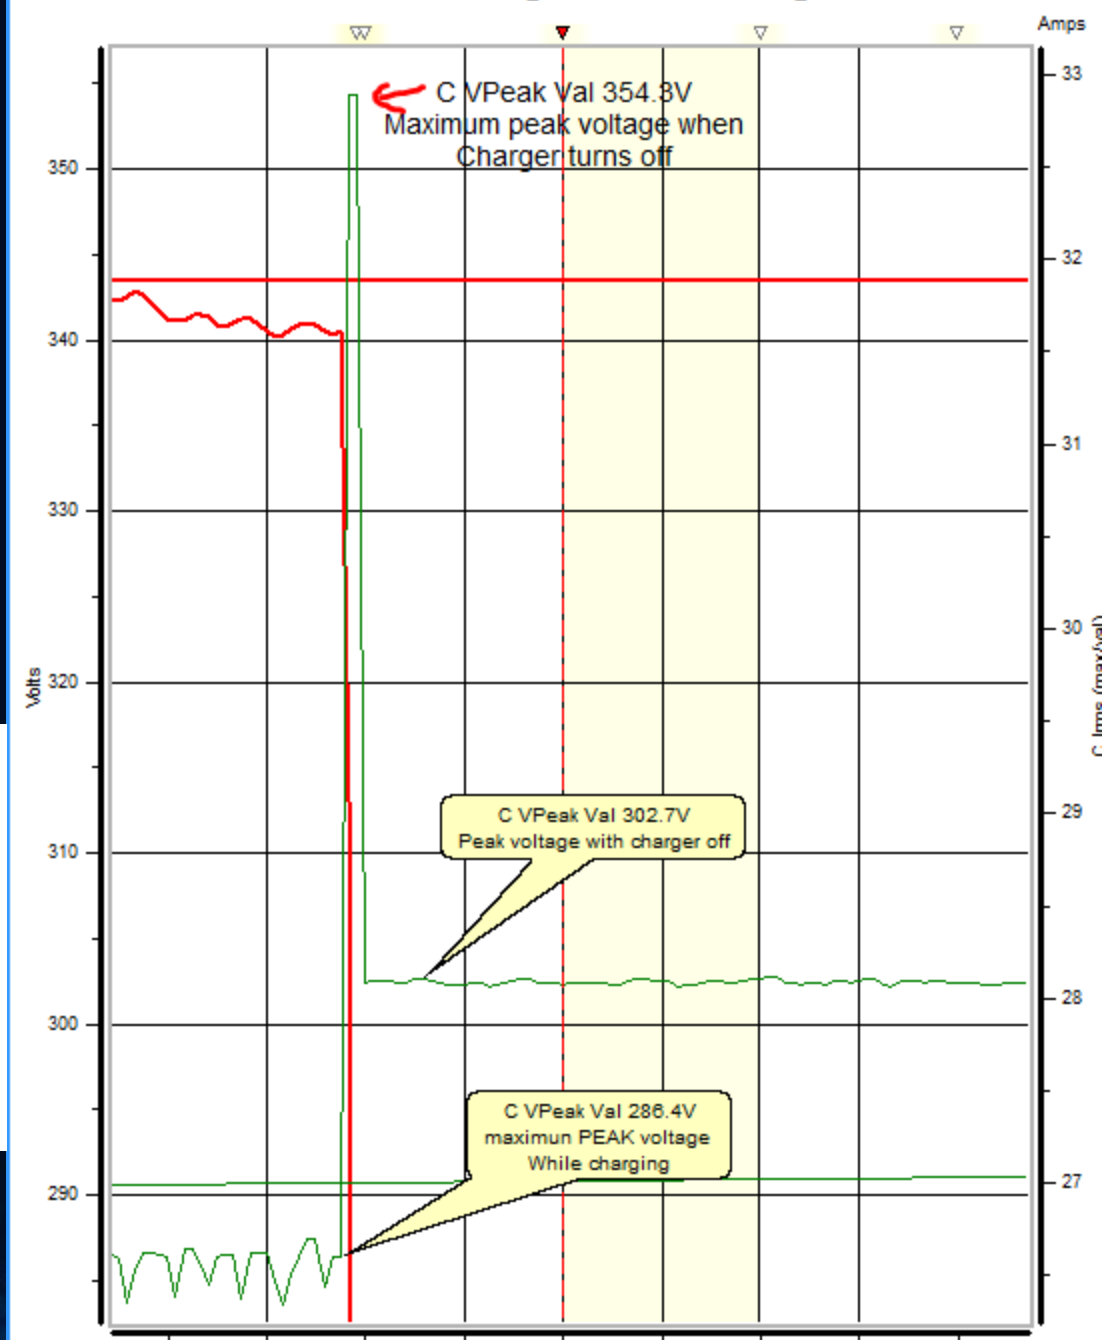
RMS voltage and peak of cycle voltage when charger turns off the current during maintain charge time

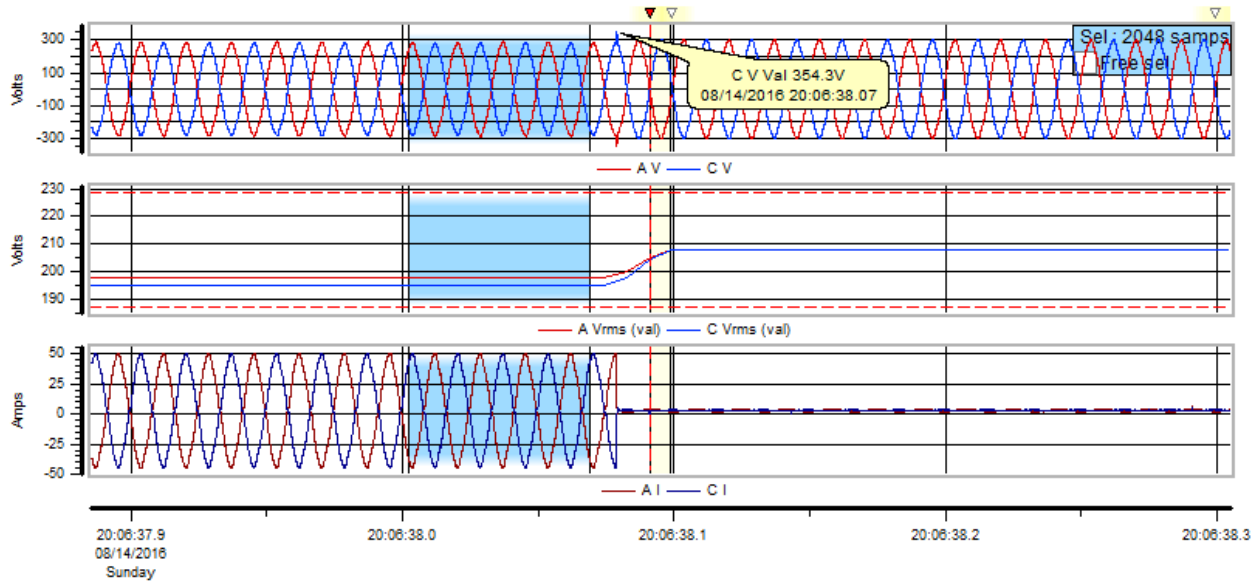
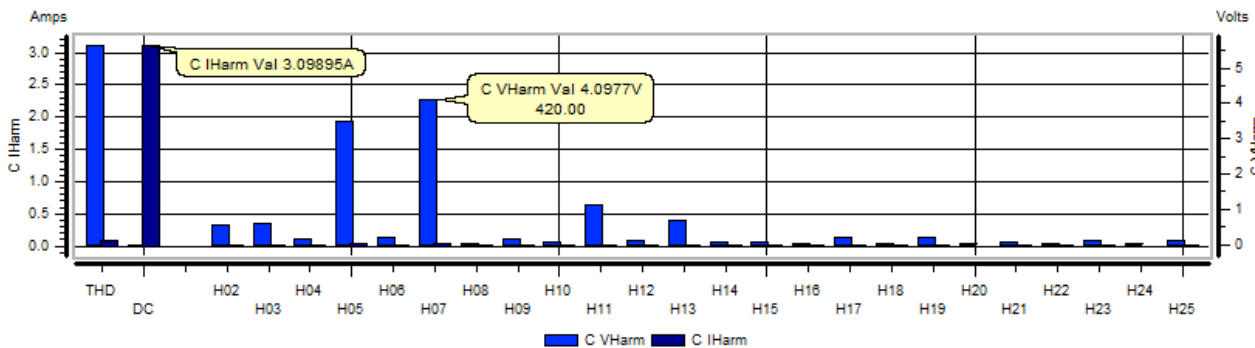
voltage before and after the charger current turns off

Waveform harmonics

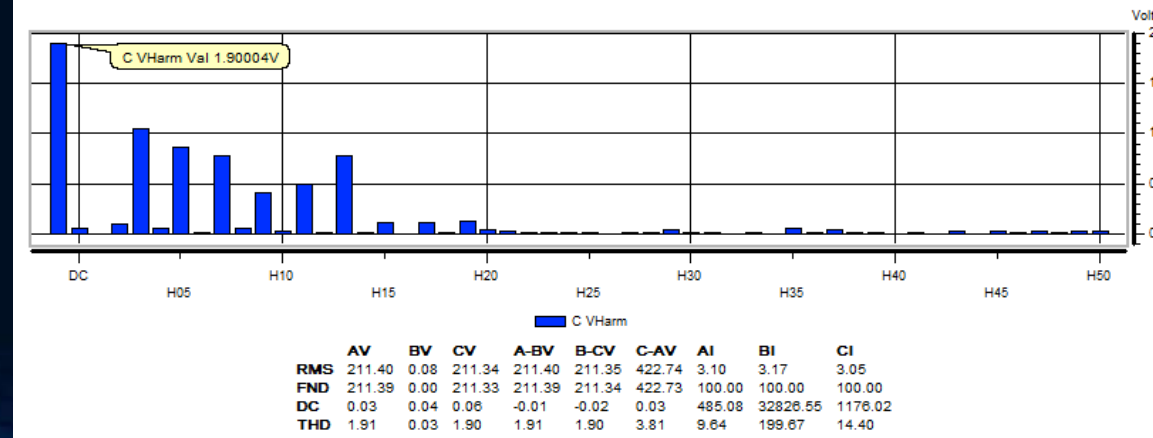
Peak of RMS voltage occurs after the charger current is off

Waveform harmonics

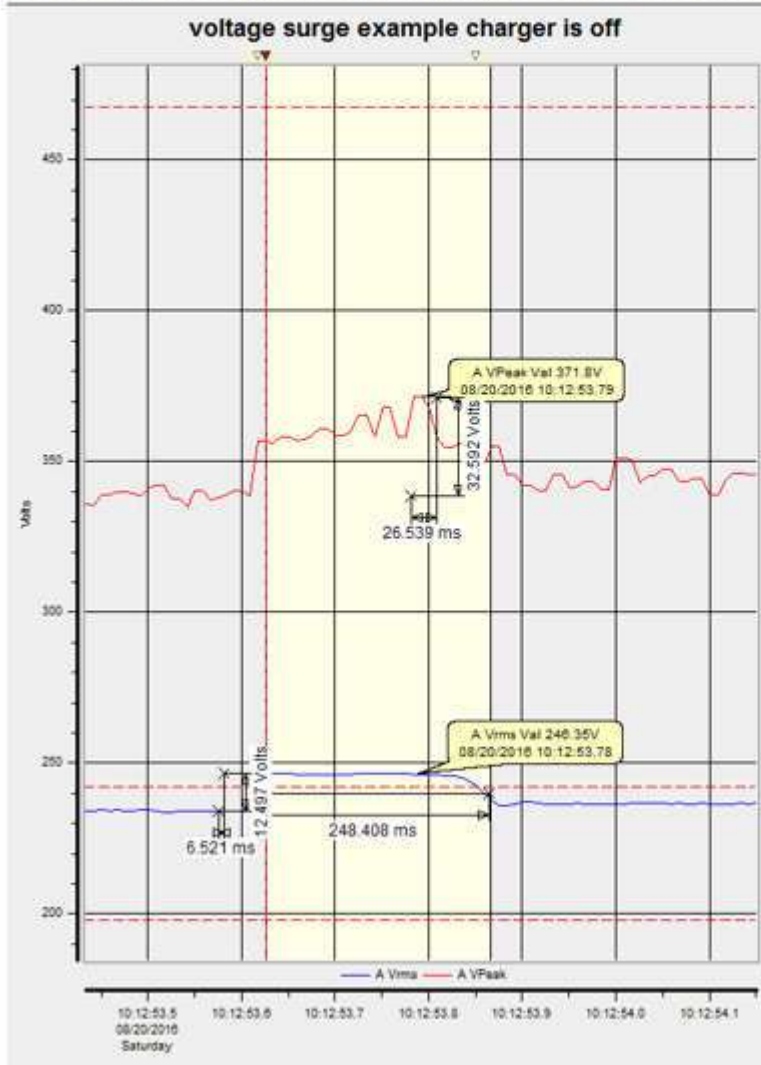
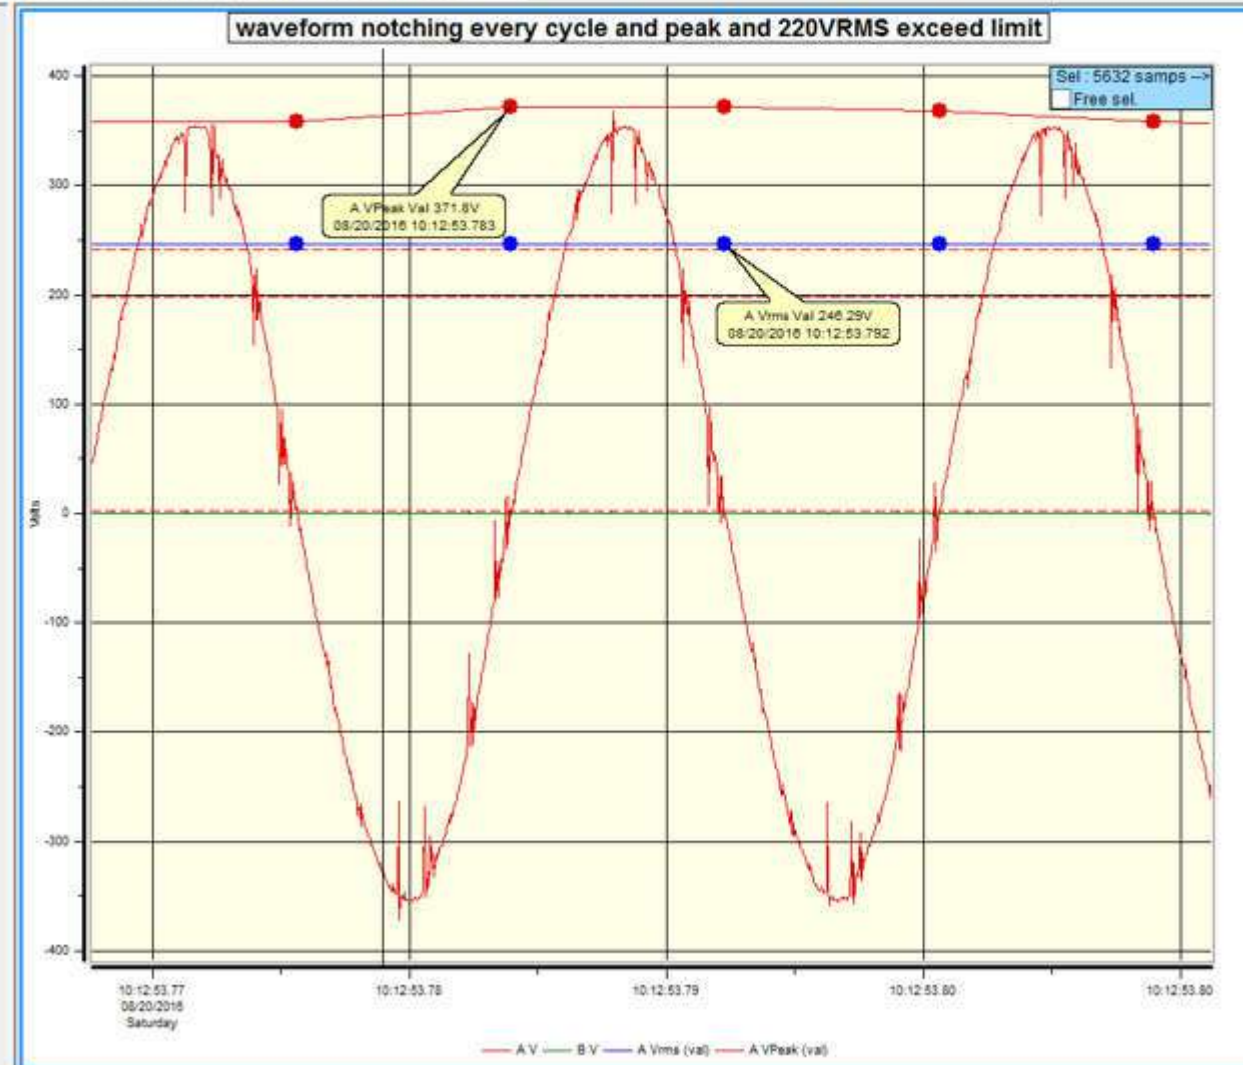
Voltage surge and sever notching of waveform RMS value and Waveform peak exceed 220vac limits of +10% and -10%

EVSE input output GM KOREA\_session19 time corrected plus vrms thd plots

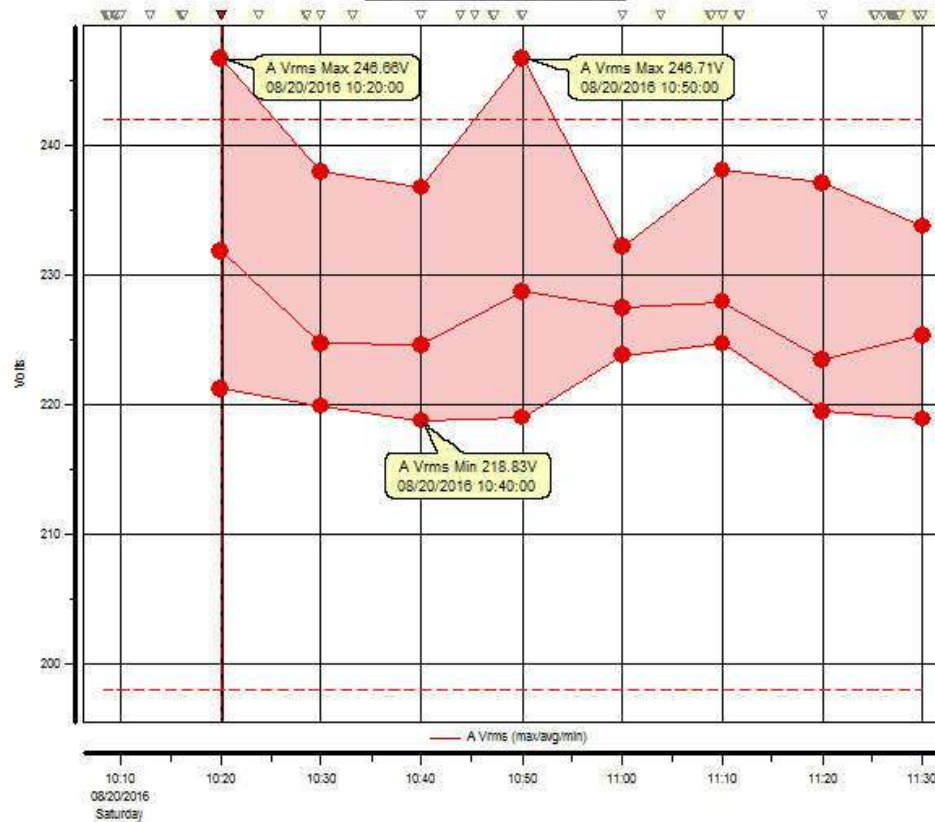
# Voltage rise during test not due to testing of charger post or charger

Monitoring Vrms during charger testing long term graph show Voltage surge during the charger connection test. No voltage sags occurred.

Input Vrms 220V nominal 10 am to 11:30 am

Min	Max	Avg
A Vrms	218.8	246.7	227.0

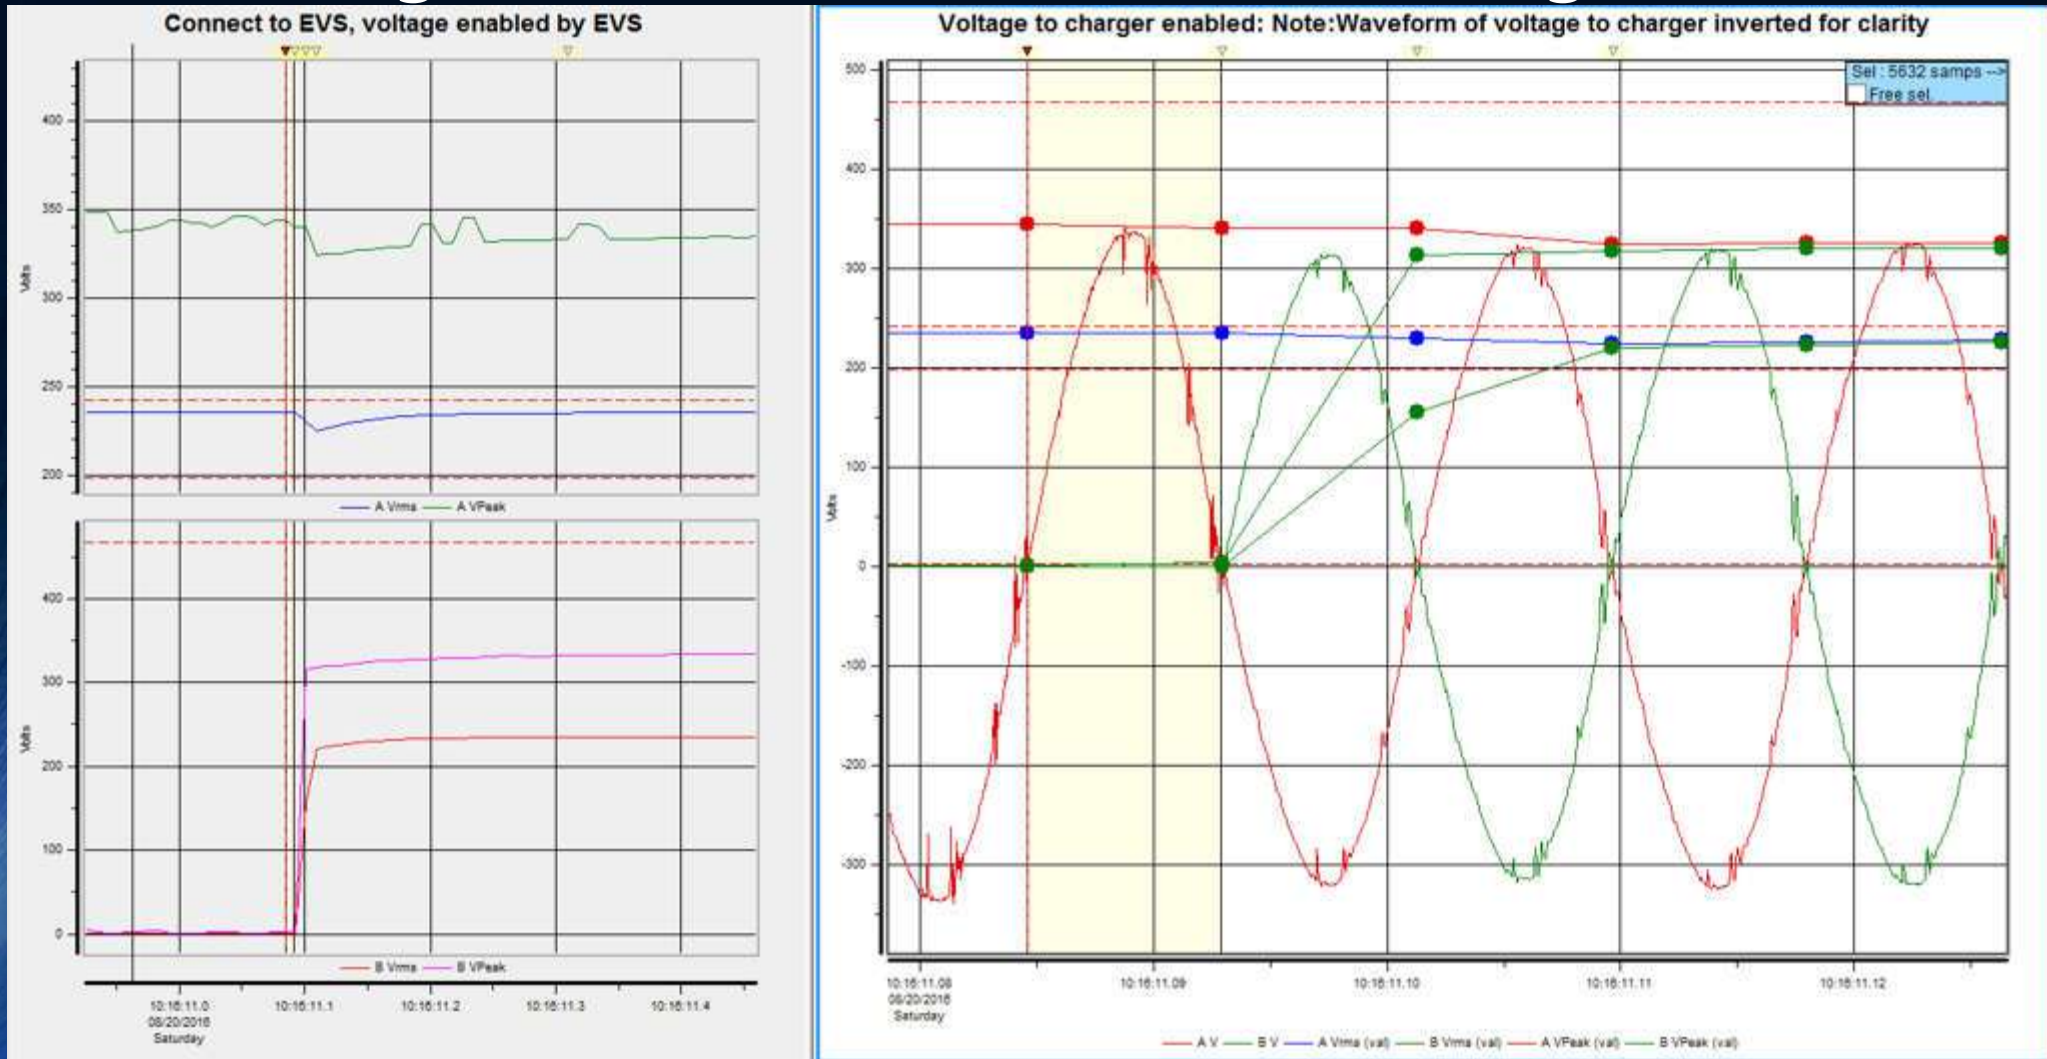
# Voltage rms and waveform during test

Green graph is peak voltage and waveform every half cycle, red graph waveform is source voltage, blue

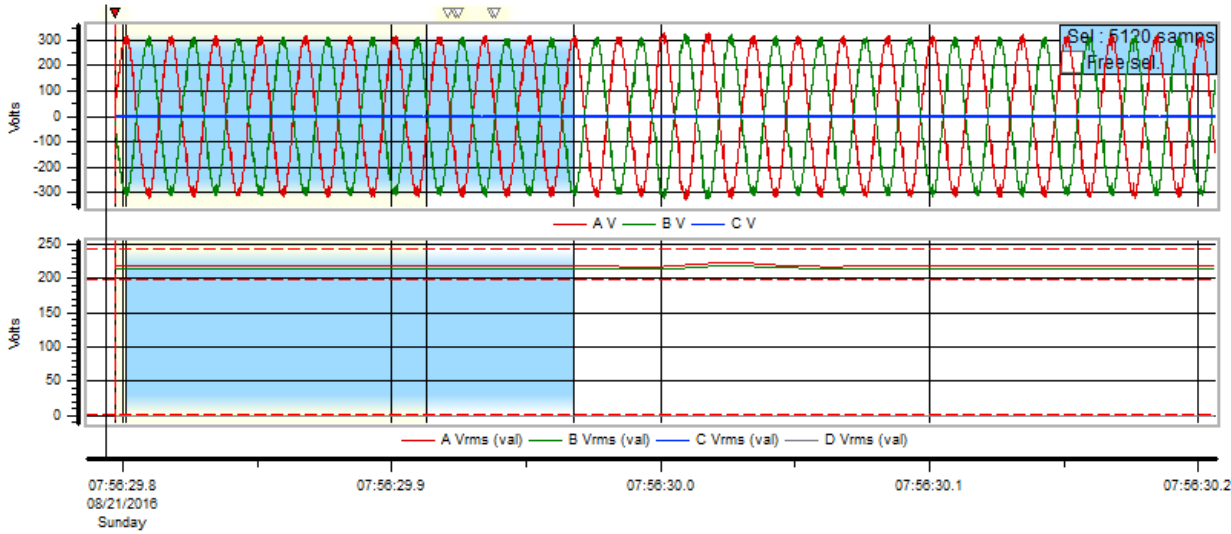
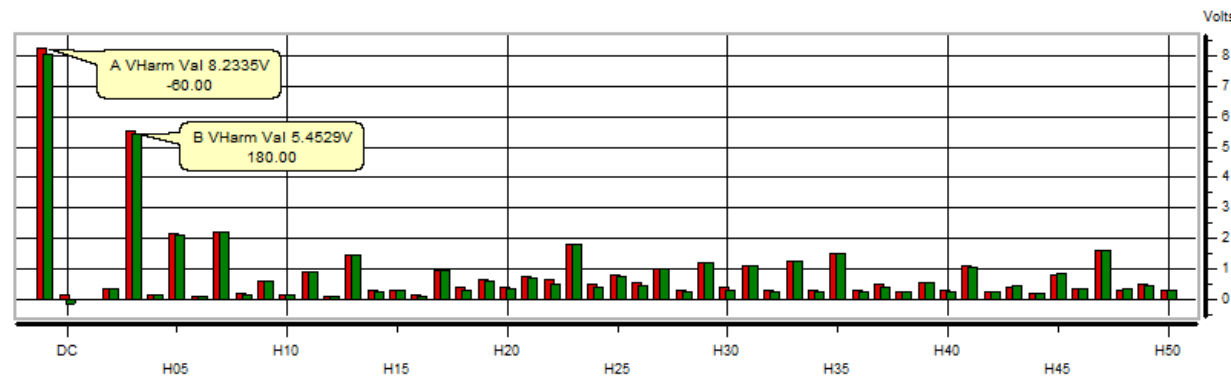
charger on

Event #428 at 08/21/2016 07:56:29.798  
Pre-trigger

Waveform harmonics

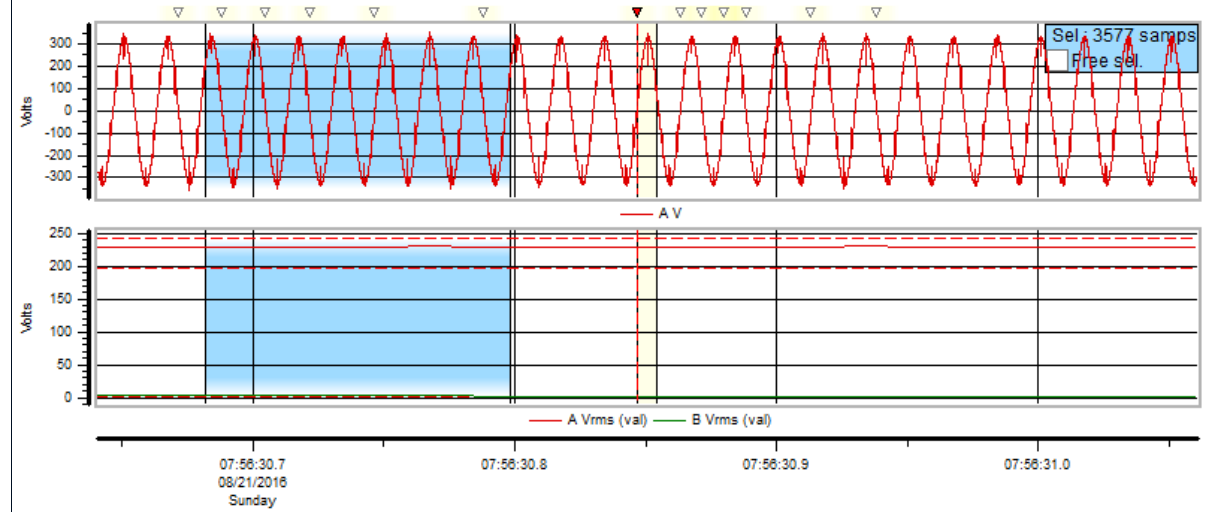
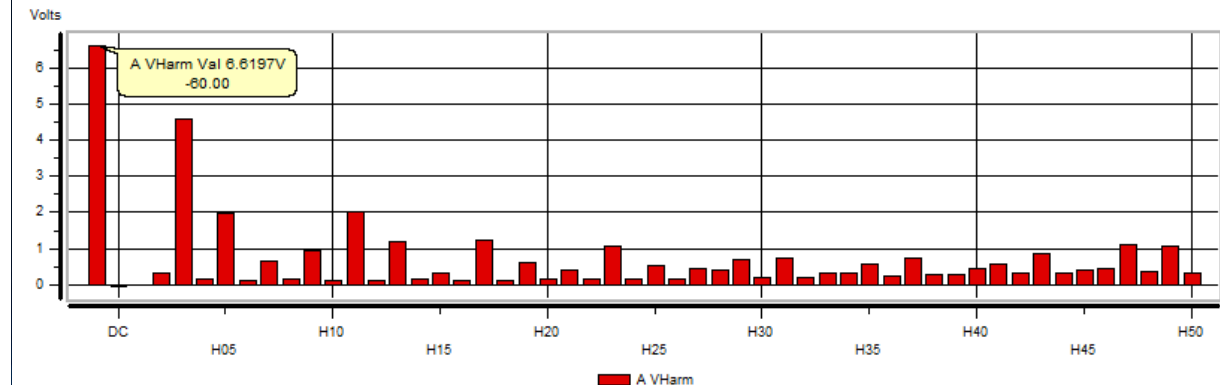
charger off

Event #456 at 08/21/2016 07:56:30.846  
AVPeak Normal To High  
Threshold crossed 350.0

Waveform harmonics

- Source voltage is fed direct to EV charger without filtering, regulation or surge protection.
- Harmonics increase when EV charger comes on is dependent on the source impedance and will vary site to site.
- The EV chargers are at risk to damage due to source voltage PQ events.
- Not all source voltage PQ issues are from the utility
- Some charger sites have transient voltage surge suppression.
- The EV charger loads will vary by EV manufacturer. Tested units showed charger current and supply voltage from the charger post are controlled by the EV charger
