20th Annual PQSynergy™ International Conference and Exhibition

A Case Study and Analysis on Low Voltage Air Circuit Breaker Unreasonable Automatically Trip

CUSTOMER SERVICE DIVISION PEA AREA 3 (NORTH) LOBURI PROVINCE

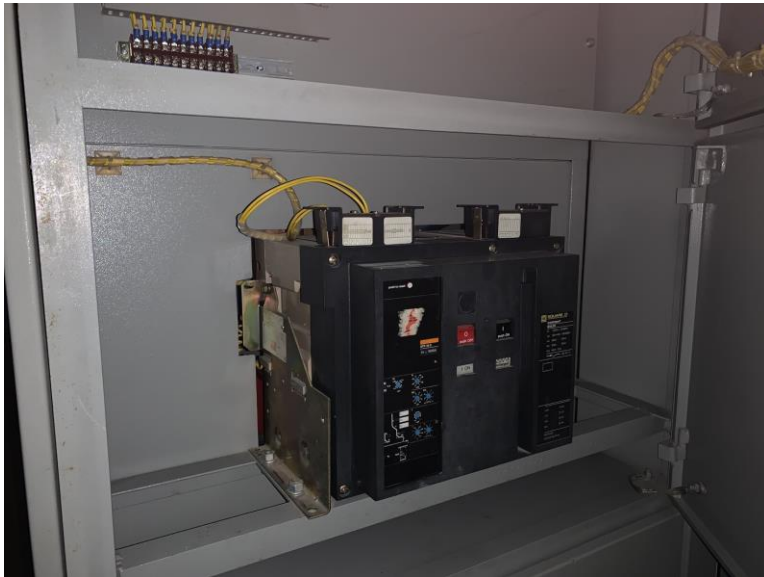
- ▶ We were informed that the electric shutdown around 6 O'clock almost everyday.

- After we discover cause of electric shutdown we found ACB opened circuit. However, after check electric system in the building, not found abnormal things. Then we charged spring for operate closed circuit. ACB either can operate to close circuit within 1 time or need many times to operate close circuit. Despite that when we operate close circuit in a moment it opened .
- We try to figure out the hot spots in electrical systems by using a thermal camera, but don't have any hot spot in electrical system.

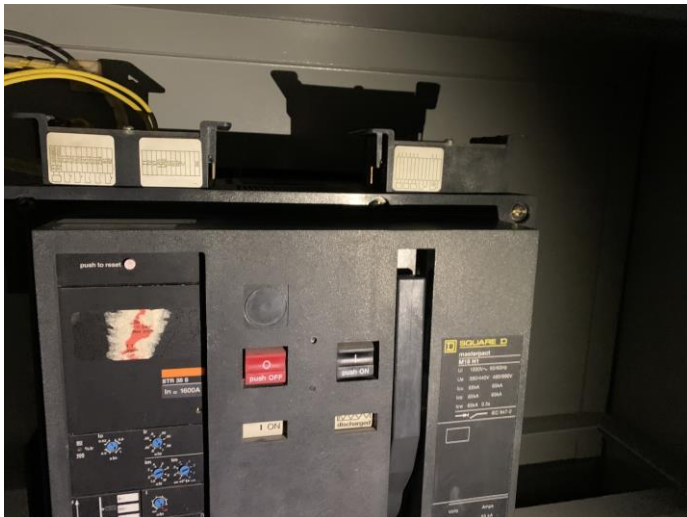
ACB: Square D master pact 16M H1, 1600AT, fixed type

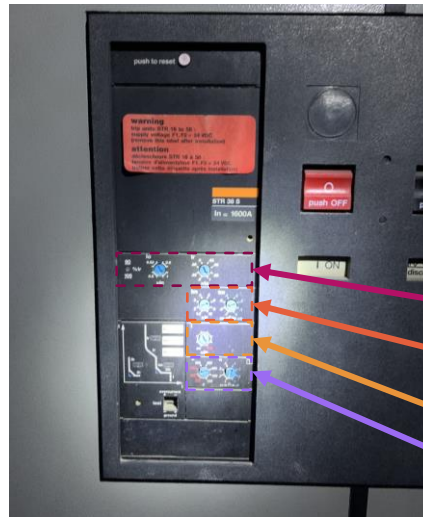
Trip unit: STR 38S (Isig)

Current protection

- Long time
- Short time
- Instantaneous
- Ground fault

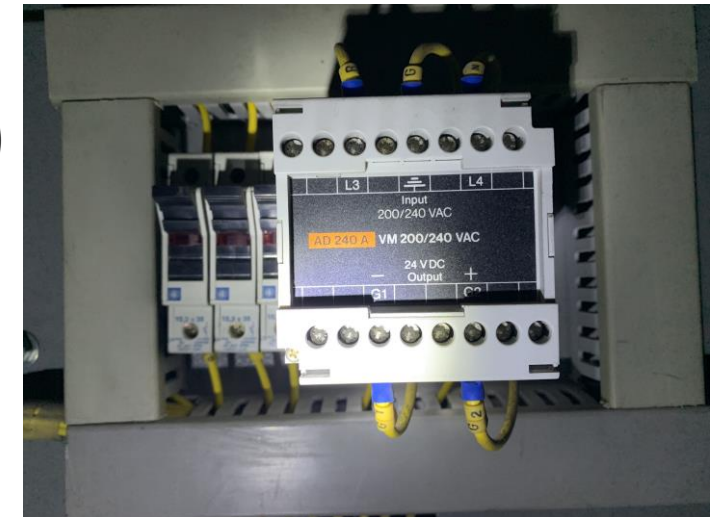
Power supply 24VDC for Trip unit:
Generac AD 240 A VM Relay 200/240 VAC

Without UVR (under voltage release), Shut trip ,voltage protection motor mechanism, and auxiliary contacts.

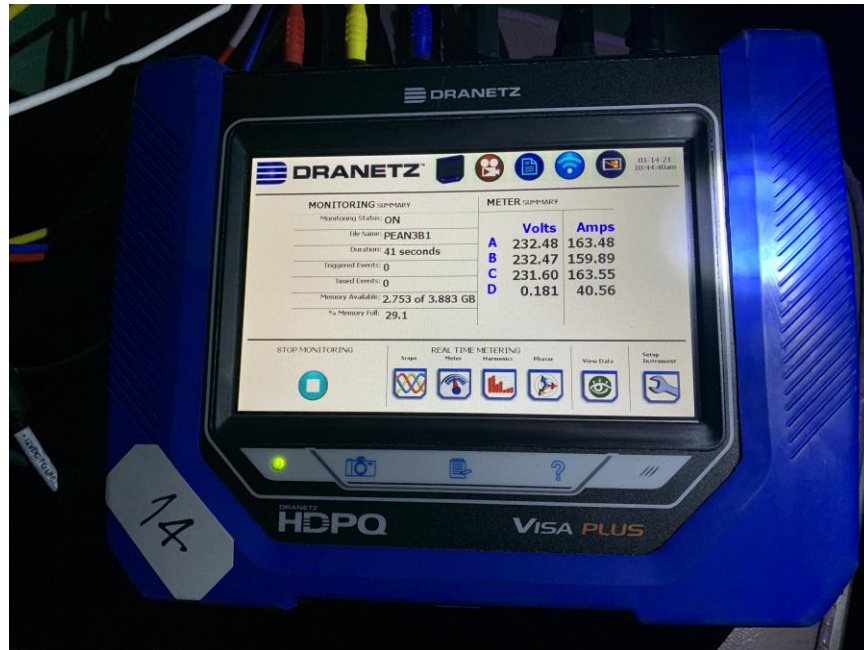
- Install power quality meter during 14 Jan to 24 Apr 2021

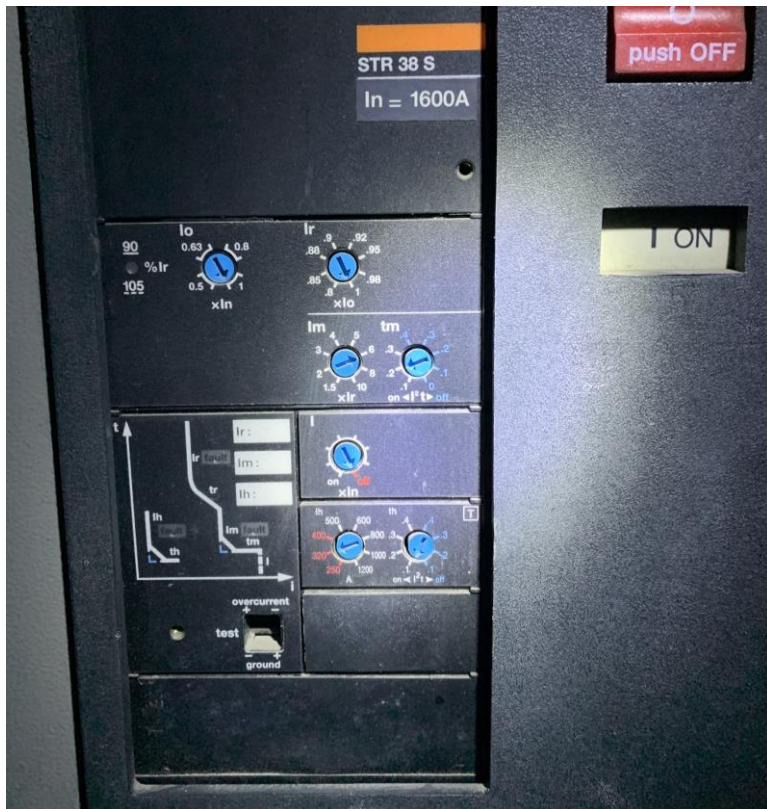
The trip unit: LSIg setting

Trip unit:
STR 38S (lsig)

Current protection setting

- (lr): setting 1600 A
- (lm): setting 9600 A
- (l): setting off
- (lh): setting 320 A

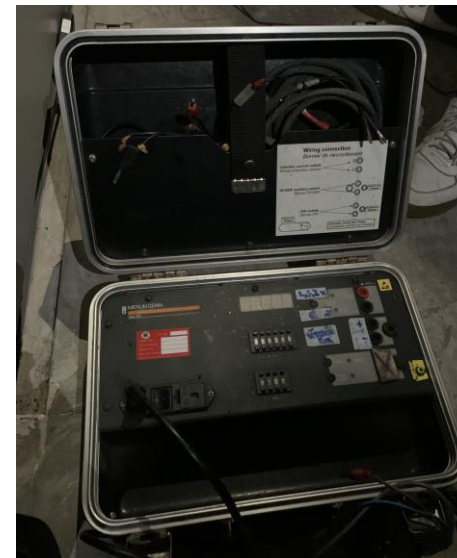
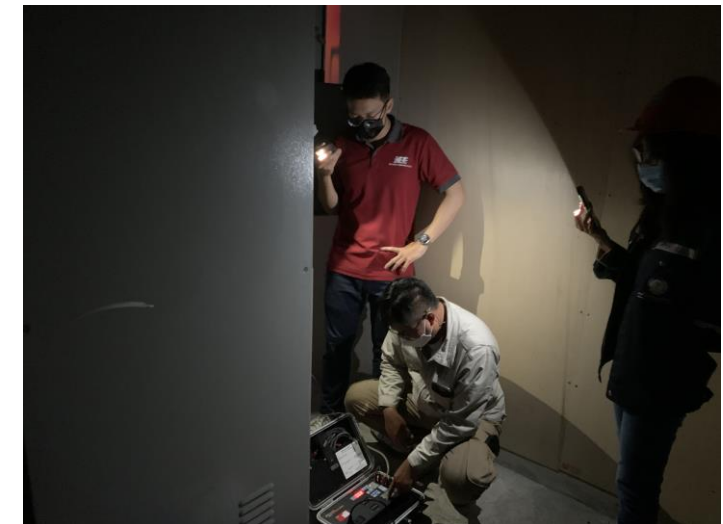
The trip unit: LSIIG testing results

- Cleaning and inspection :	Normal				
- Re-tightening torque :	Normal				
- Grounding checked :	Normal				
- Mechanism checked :	-		Abnormal MECHANIC PART ไม่ทำงาน

- Mounting and conductor connection checked :	-		Abnormal มีการถอดสายคำสั่งชุดตัดการทำงานออก		
- Cable and wiring checked :	Normal				
- Arc chute checked :	Normal

- LV Auxiliaries plug checked :	Normal				
Relay testing :					
	Current test (A)	Trip time (S)	Time Cure (S)	Status	
Long time	800	145	-	FAIL	
Short time	800	0.54	0.08 - 0.12	Pass	
Instantaneous	OFF	OFF	OFF	OFF	
Ground fault	100	0.38	0.16 - 0.24	Pass	
Contact resistance testing :

Long time : **FAIL**
Short time : **Pass**
Instantaneous : **OFF**
Ground fault : **Pass**

- ▶ The preventive maintenance of electrical equipment is very necessary, such as the ACB equipment above, has been in use for 20 years that probably a malfunction with unit trip.
- ▶ We should replace the ACB before its life expectancy to avoid a power outage. Because there is very difficult to find spare parts in time, and it will result in power outages for a long time.
- ▶ The ACB replacement period is 4-6 hours, requiring us to have the power outage at least for a period of time. Because you have to modify the busbar in order to install a new ACB.
- ▶ Voltage protection or Phase protection should be installed in combination with UVR and time-delay to prevent abnormal voltage events. Thus, ACB trips are possible to prevent damage to electrical equipment in the building and there over heat in some electrical equipment. This could result in a fire.
