20<sup>th</sup> Annual PQSynergy™ International Conference and Exhibition 2022. 14 to 16 Sept 2022, Bangkok Thailand

# Missing Earth Loop Impedance

# The Problem

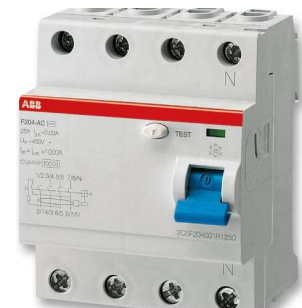
30mA Residual Current Circuit Breaker (RCCB)  
or Residual Current Device (RCD)

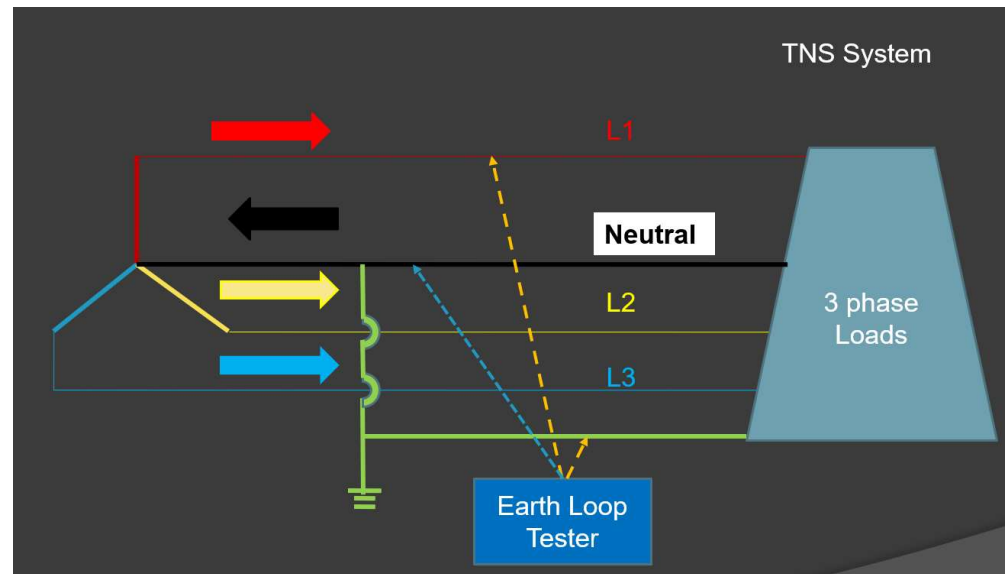
# Electrical Setup at the Shopping Mall

- MSB-X: 400V Main Switchboard served by a 2MVA 22kV/LV transformer
- TN-S Earthing System

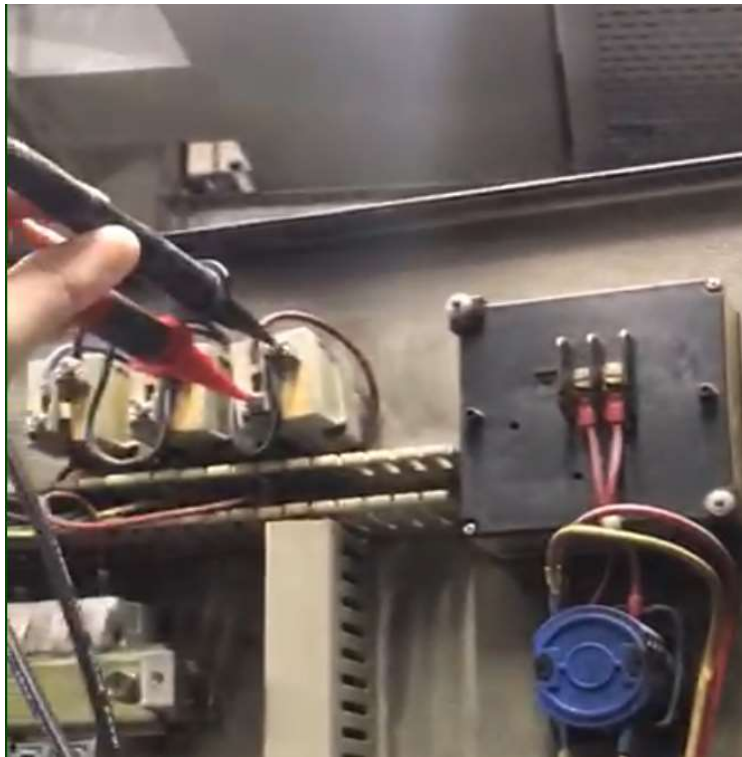
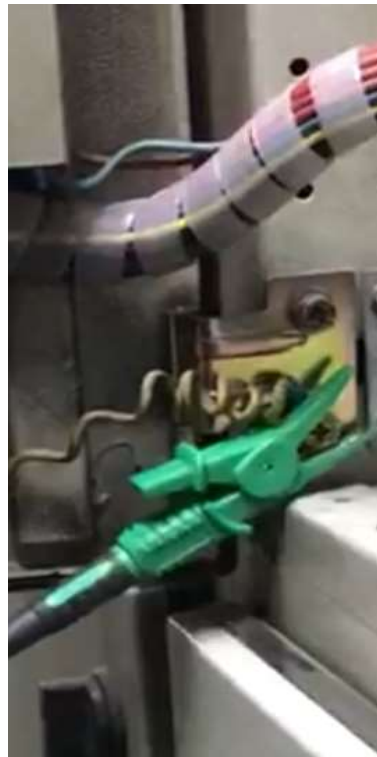
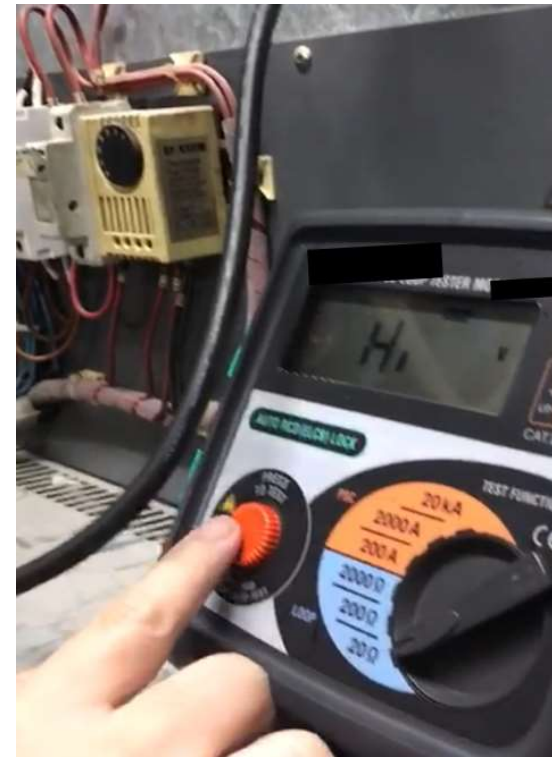
# Unable to Get Earth Loop Reading (Landlord Main Switchboard)

- Unable to achieve an earth loop impedance value when measured between 'Phase L1' and Earth (for most cases, some cases on other phases), at both tenants' side and landlord's side.
- "OL" or some error codes.
- Puzzling as value could be achieved when measured at other two phases (for most cases)
  - Between 'Phase L2' and Earth
  - Between 'Phase L3' and Earth
- Similar results for trip tests on the RCCB at Landlord's owned distribution boards.

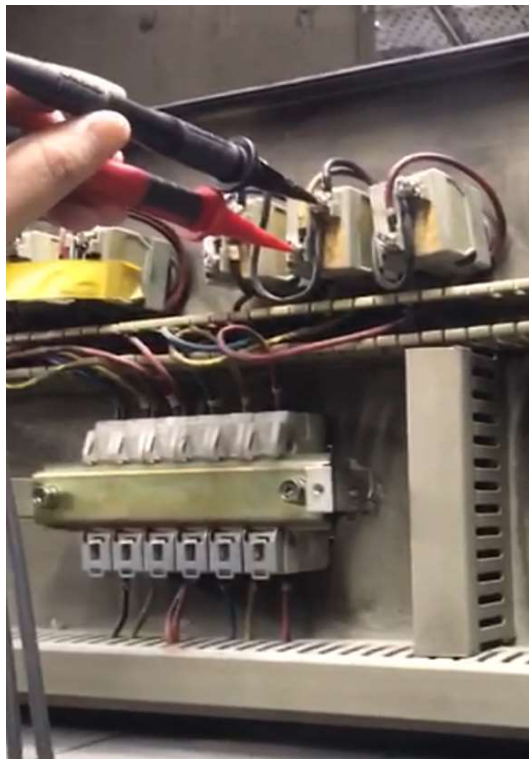
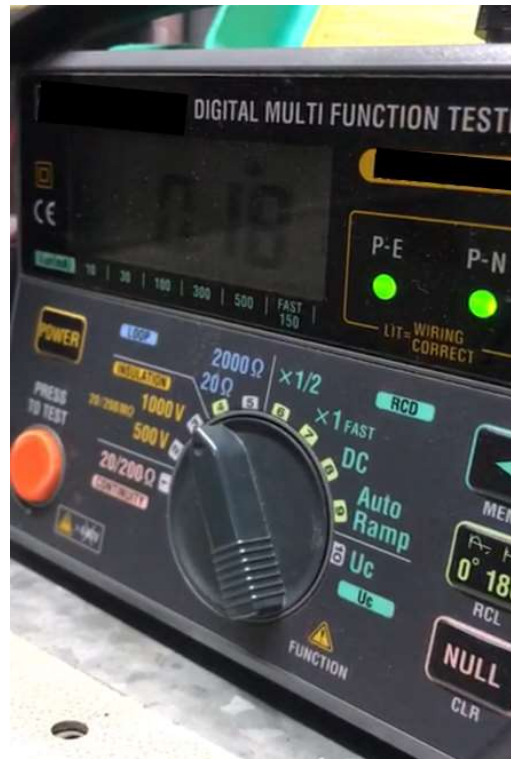
# Able to Get Earth Loop Reading (Landlord Main Switchboard)

L2-E = 0.18 ohm

L3-E = 0.16 ohm

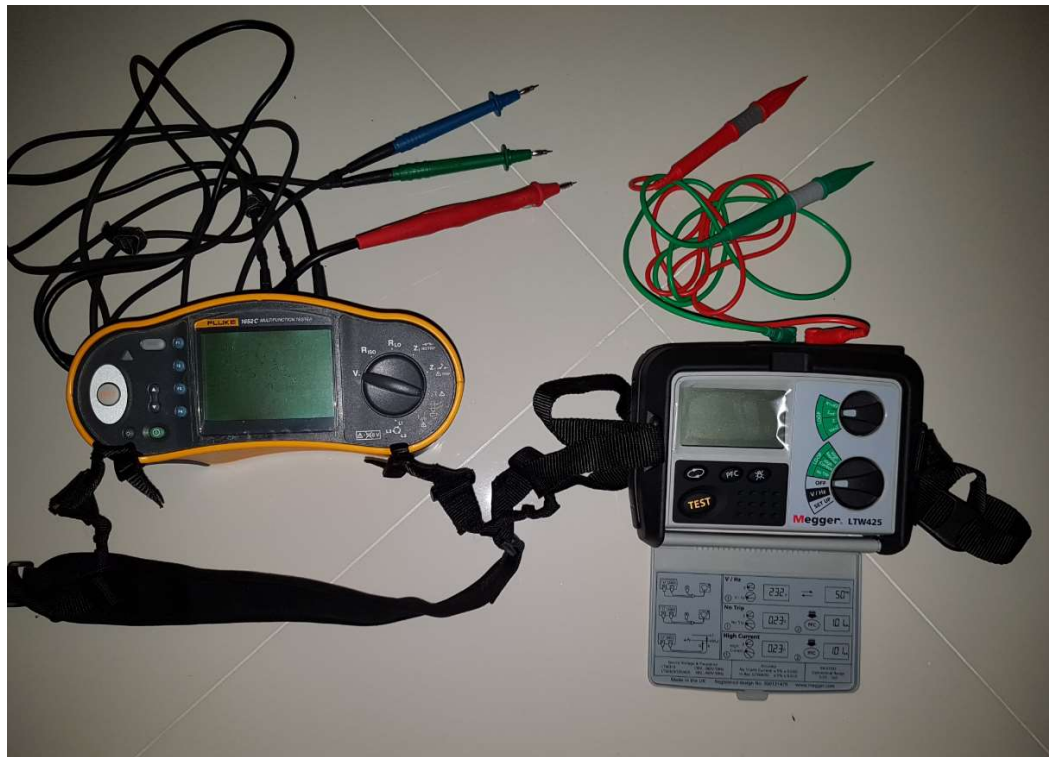
# Earth Loop Impedance Tester

- Operates by **inducing** a current from the **Supply system**, by
  - introducing a calibrated load
  - between the phase conductor and the protective earth
- And then monitors the voltage difference [  $Z = V / I$  ]

- Multifunction Tester
- Dedicated Loop Tester
- 3-wire types  
L + N + E
- 2-wire types  
L + E
- High/Low Current Type

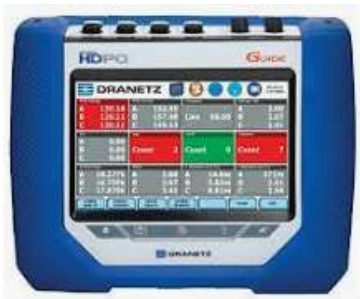
- Short-term monitoring via a Power Quality Analyzer.
- IEC 61000-4-30 Class A Dranetz HDPQ Guide.

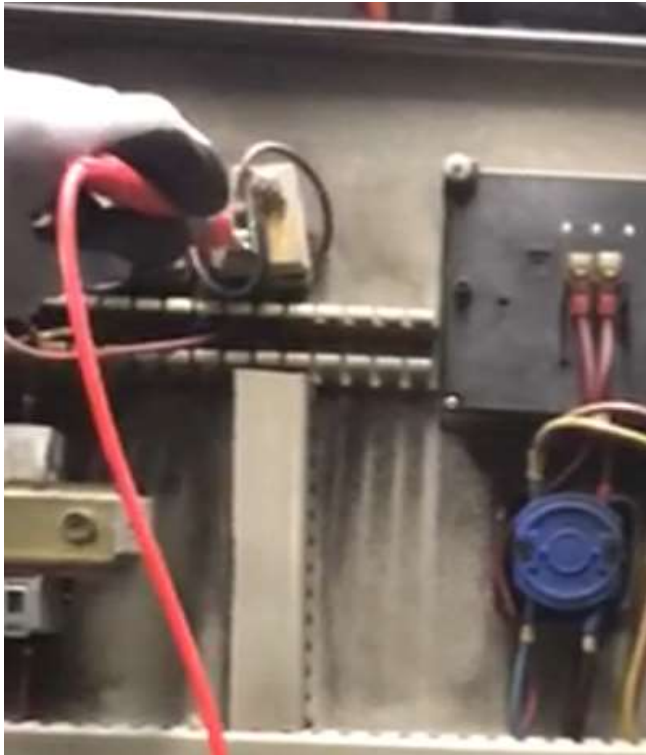
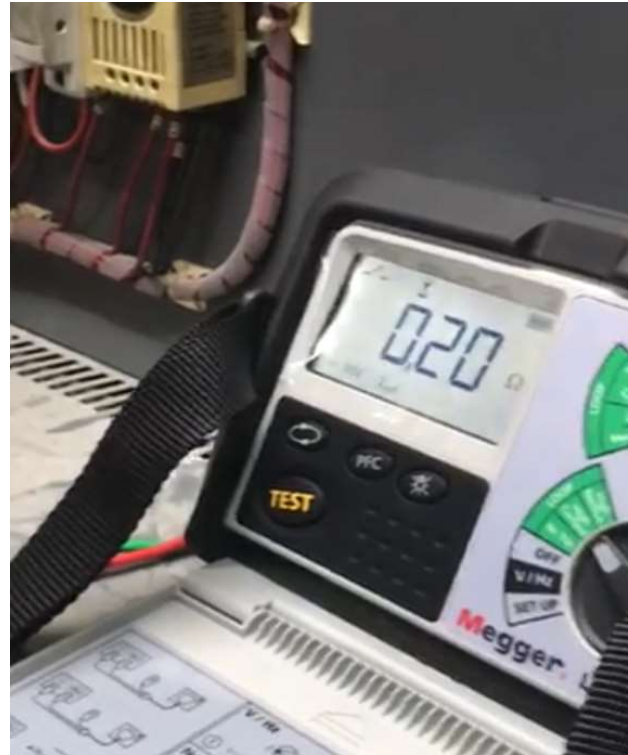
# Site Test & Measurements

- To conduct earth loop impedance tests using the two different brand/model of earth loop tester.
- To conduct RCCB trip tests via a test bulb.
  - Standard 30mA RCCB Tests:
    - 50% (15mA) of rating (No Trip)
    - 100% (30mA) of rating (Trip within 100ms)
    - 500% (150mA) of rating (Trip within 40ms)
    - **RCCB can trip for any value >50% of its rating**
- To conduct a short survey of the quality of supply via a PQ Analyzer.

S/N	Circuit	Test Equipment	Value (ohm)	Remarks
1	DB-X (taking from MSB-X)	Test Bulb rated at 110mA	-	100mA RCCB/RCD tripped on all phases
2	MSB-X	Megger LTW425	L1: 0.20 L2: 0.13 L3: 0.18	Values were similar and consistent when repeated at MSB-X and DB-X
3	DB-X	Fluke 1652c		First earth loop test failed to get a value for L1-E. Subsequent tests showed similar values obtained as per using LTW425

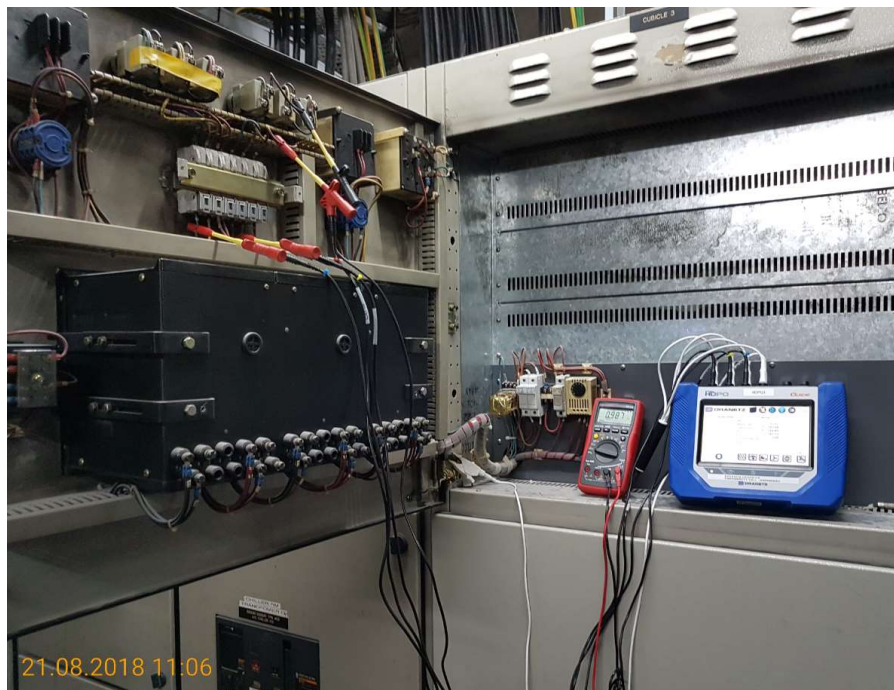
# Monitoring Quality of Supply at MSB-X

- **For Short Monitoring**
- Harmonics: 3s
- Voltage/Current/Power: 1 min
- Snapshot: On

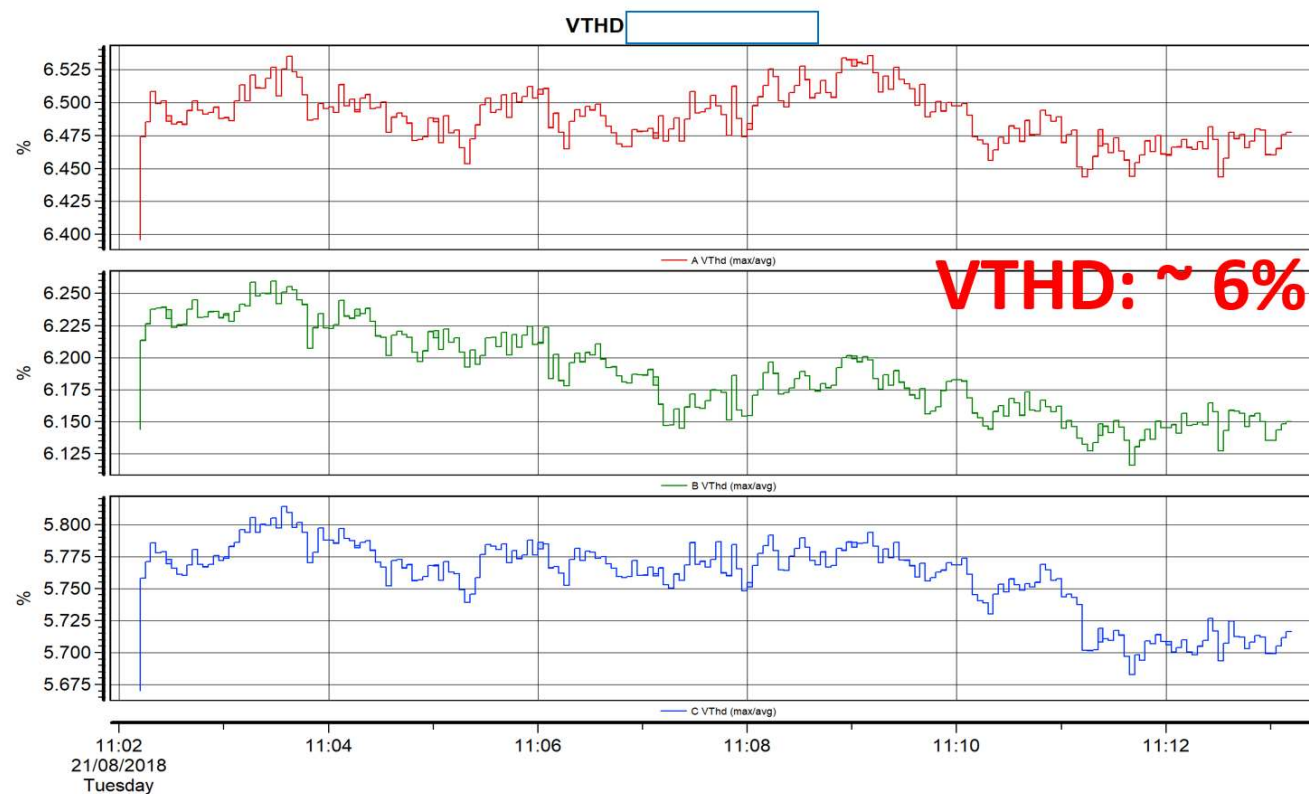
# VTHD Trend at MSB-X

Min	Max	Avg	95%	99%
<b>AVThd</b>	6.396	6.536	6.489	6.525	6.534
<b>BVThd</b>	6.116	6.260	6.187	6.242	6.255
<b>CVThd</b>	5.670	5.814	5.759	5.796	5.805

- The quality of supply waveform on Phase L1 affected / influenced the operability of the other earth loop testers, resulting in “OL” or other error code readings.
- Newer earth loop testers do have ‘harmonic component’ to cater for (IEC 61557-3:2007).
- When the chiller system is not in operation, earth loop values were able to be obtained, regardless of the earth loop test equipment model used.
- RCCB / RCD testers work in similar manner like an earth loop impedance tester but are designed to induce “fault current” at a much smaller value, in terms of milliamperes. Hence, affected in the similar manner.

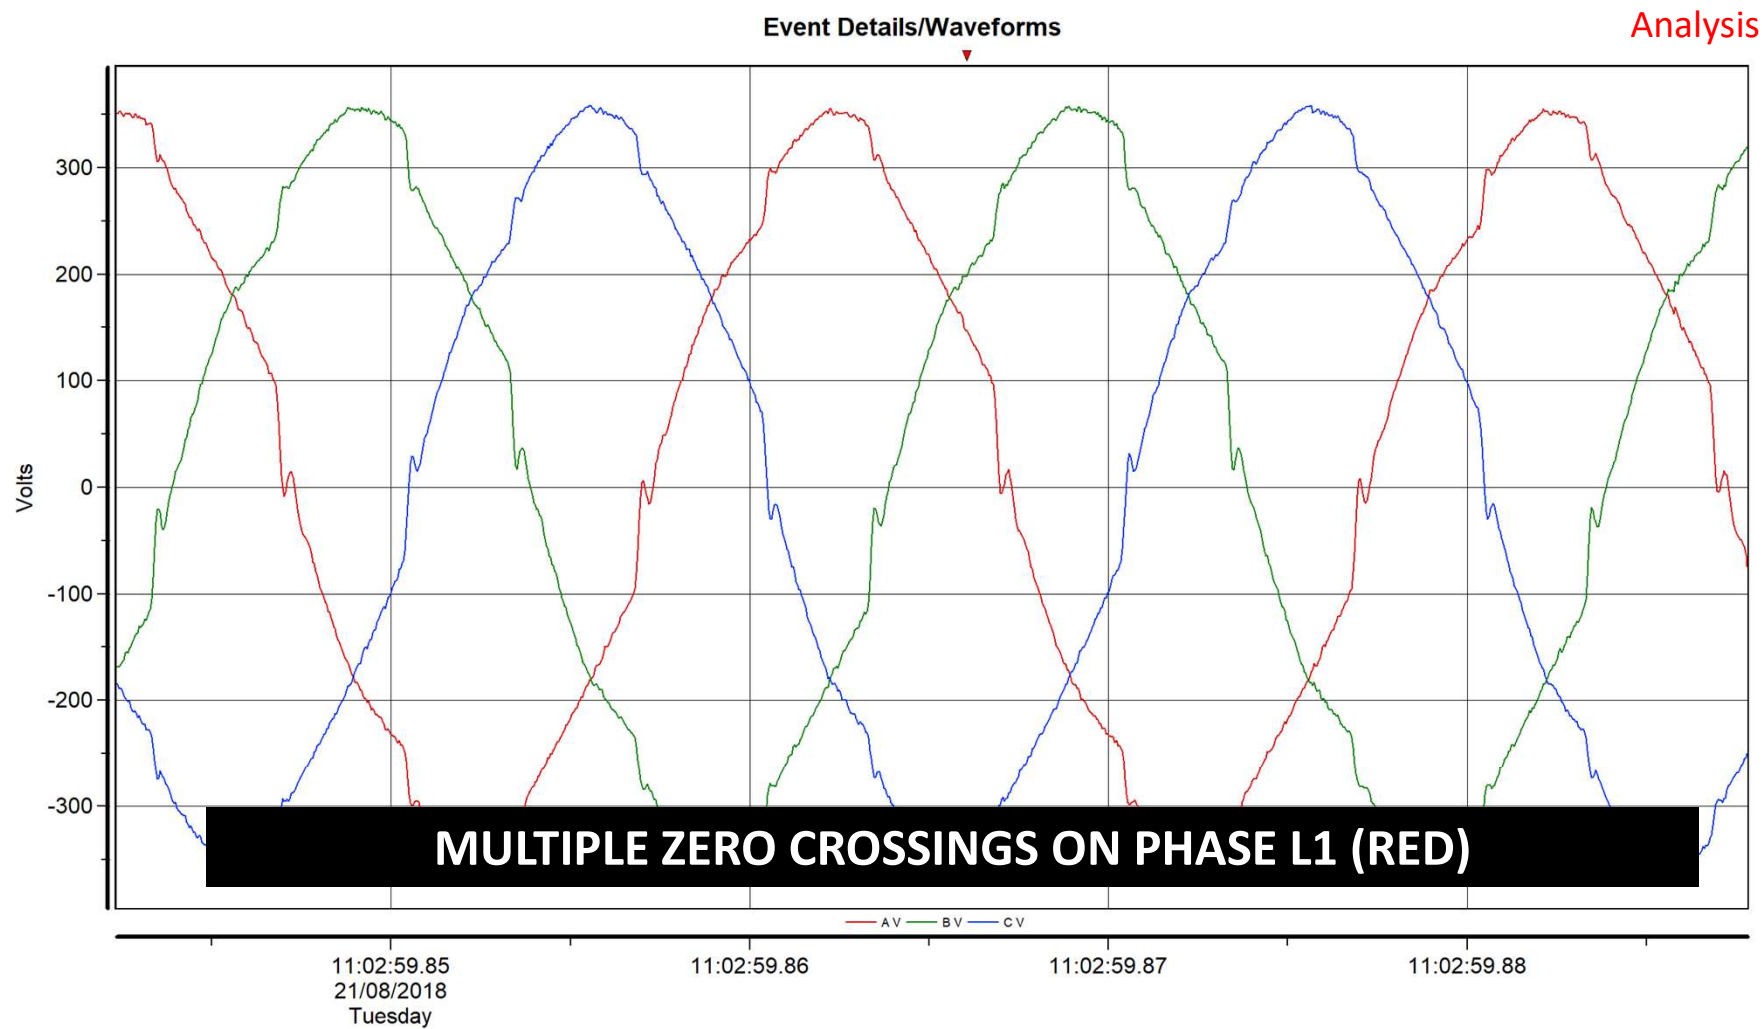
Event #8 at 21/08/2018 11:02:59.857  
AV Dropout 1/16 Cyc  
Phase 315.0 Deg

A	B	C	D	A-B	B-C	C-A
Vrms	241.9	245.2	245.1	3.127	419.9	424.8	423.3
VPeak	356.6	358.1	358.7	9.502

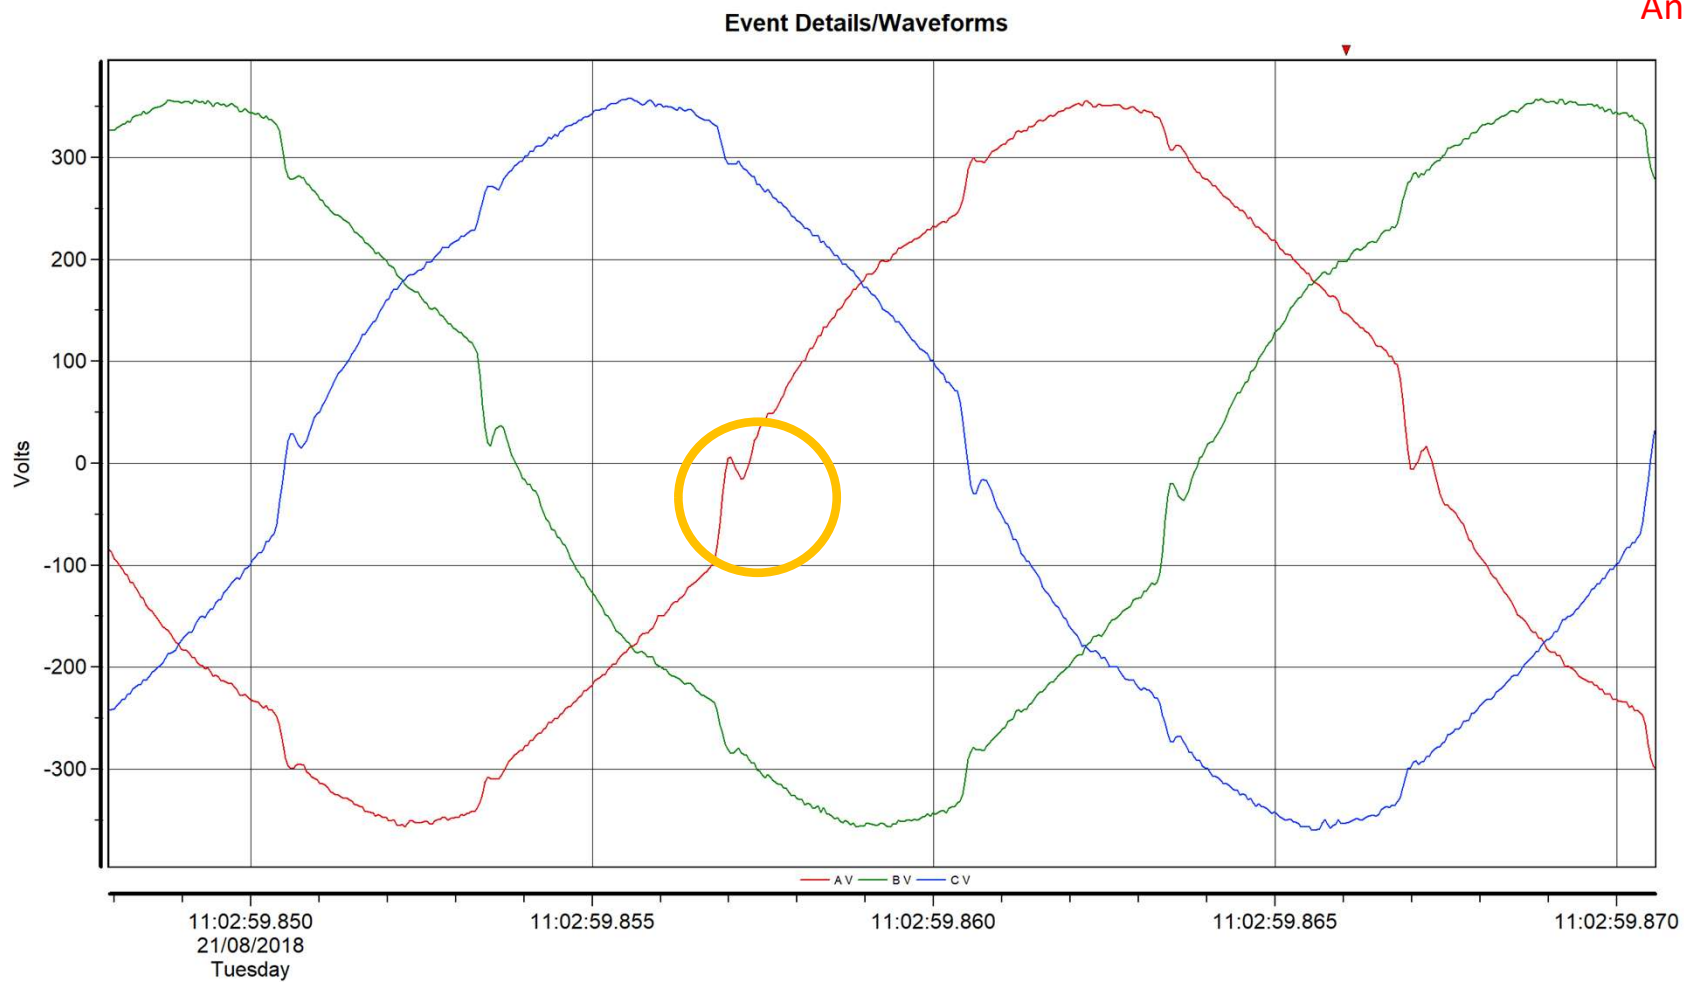
## Analysis

Event #8 at 21/08/2018 11:02:59.857  
AV Dropout 1/16 Cyc  
Phase 315.0 Deg

A	B	C	D	A-B	B-C	C-A
Vrms	241.9	245.2	245.1	3.127	419.9	424.8	423.3
VPeak	356.6	358.1	358.7	9.502
